**2014-2015 Ice Observation Survey
Mud Lake Crossing, Lower Churchill River
LC-EV-107**

Sikumiut Environmental Management Ltd.

August 28, 2015

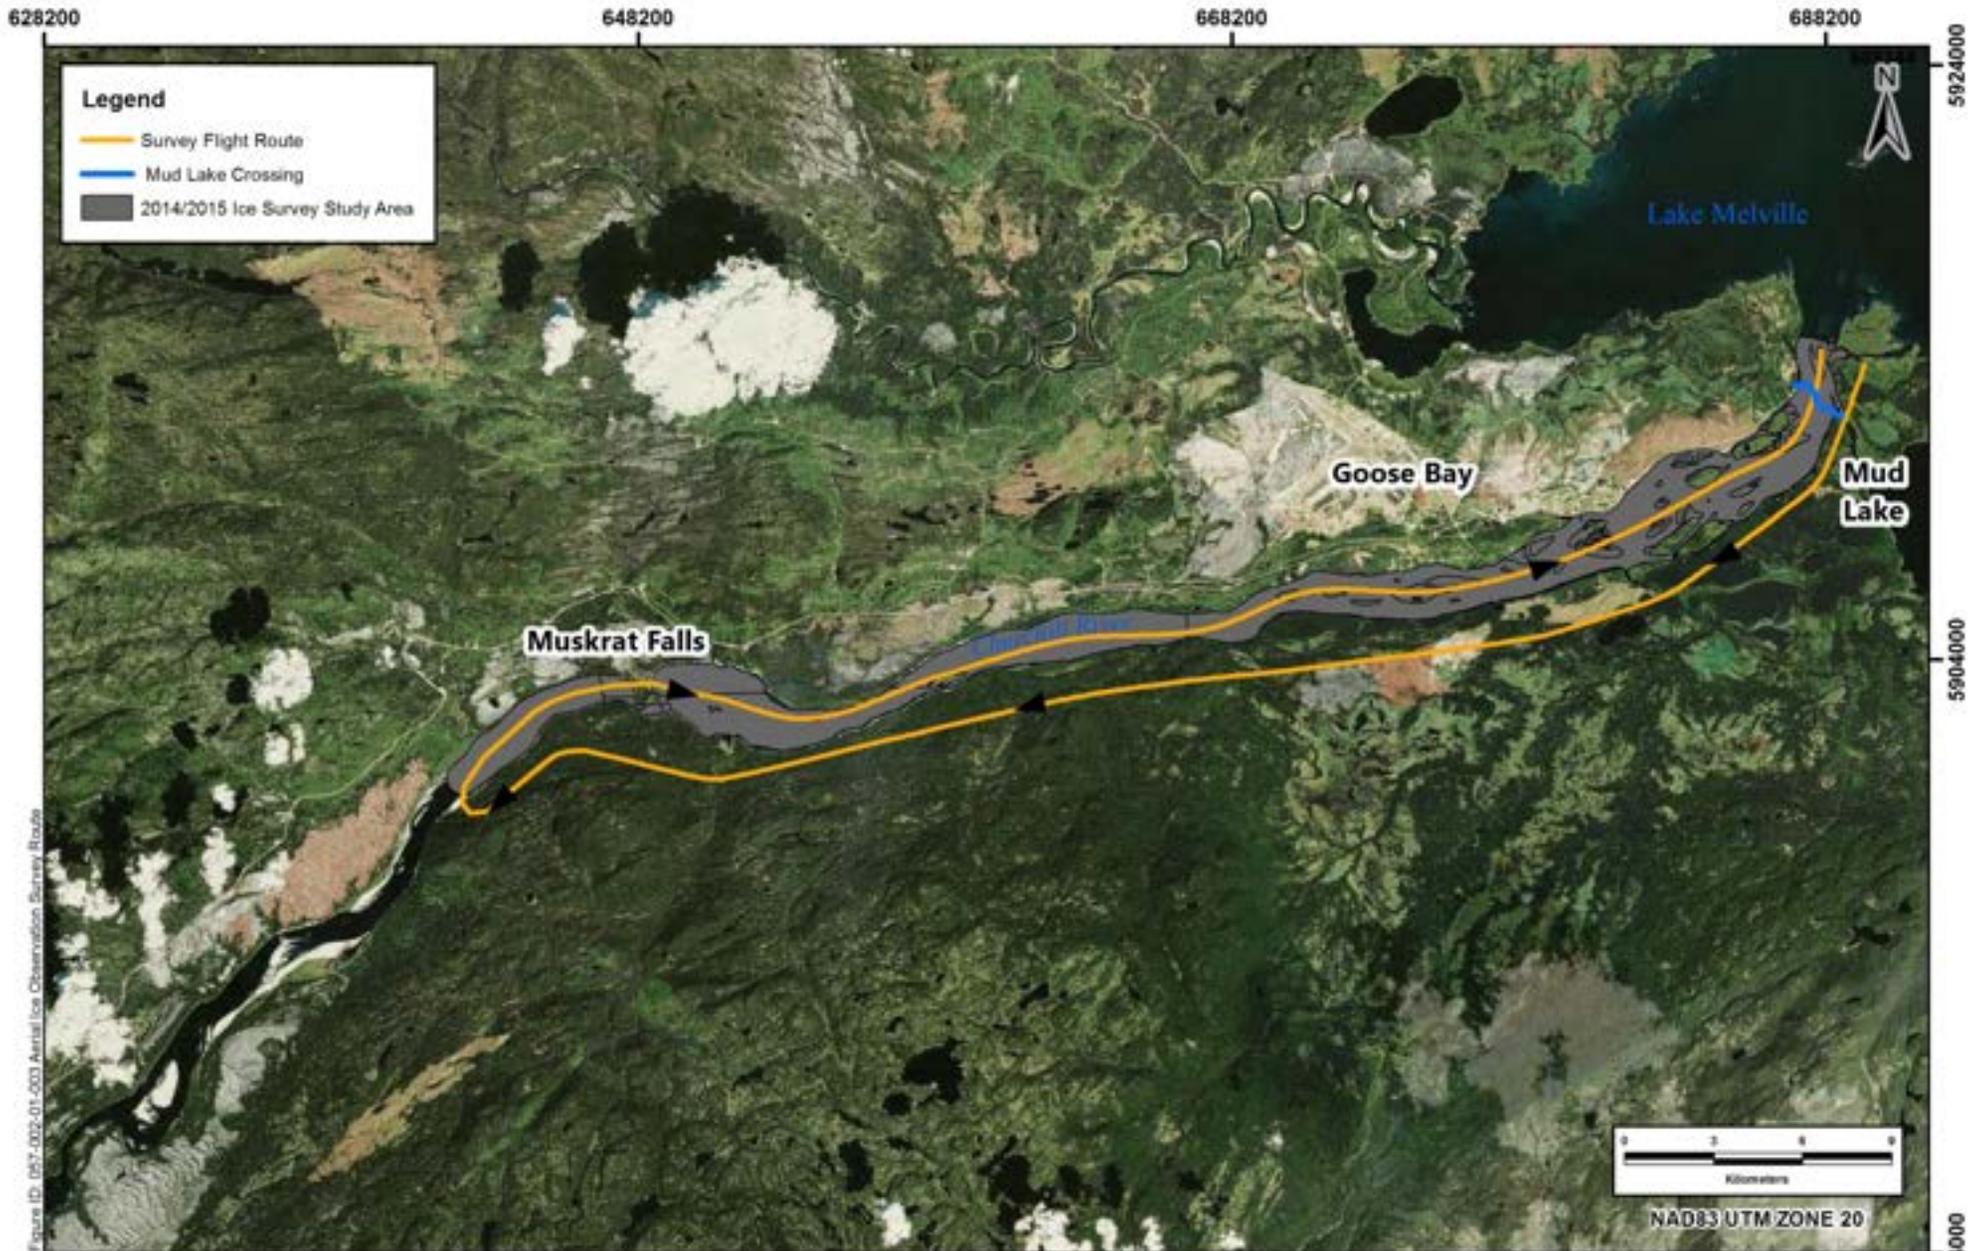
During the ice freeze-up period, daily helicopter (Bell 206 Long Ranger) surveys were completed between November 22 to 25, 2014, to observe the ice conditions from Lake Melville, past Mud Lake and Goose Bay, and up to Muskrat Falls. The surveys were completed at approximately the same time each day (between 12:00 to 15:00) with the helicopter flying at the same altitude (800 to 1,200 m above sea level [masl]). The process for photographic documentation of the ice freeze-up had the helicopter travelling along the southern bank of the lower Churchill River while the SEM team took continuous side view photographs (Figure 2.2). On the return trip, the helicopter flew down the centre line of the river and the SEM team took photographs at approximately 2 km intervals, looking down river and encompassing views from bank to bank (Figure 2.3). Global Positioning System (GPS) locations were logged along the route at each photograph location to ensure consistency between photographs during the three day survey for the ice formation period. While at Mud Lake, additional photographs were taken of the potential locations where the Mud Lake Crossing was to be placed. A total of 850 photographs were taken during the freeze-up period (234 photos on November 22; 216 photos on November 23; 205 photos on November 24; and 195 photos on November 25).

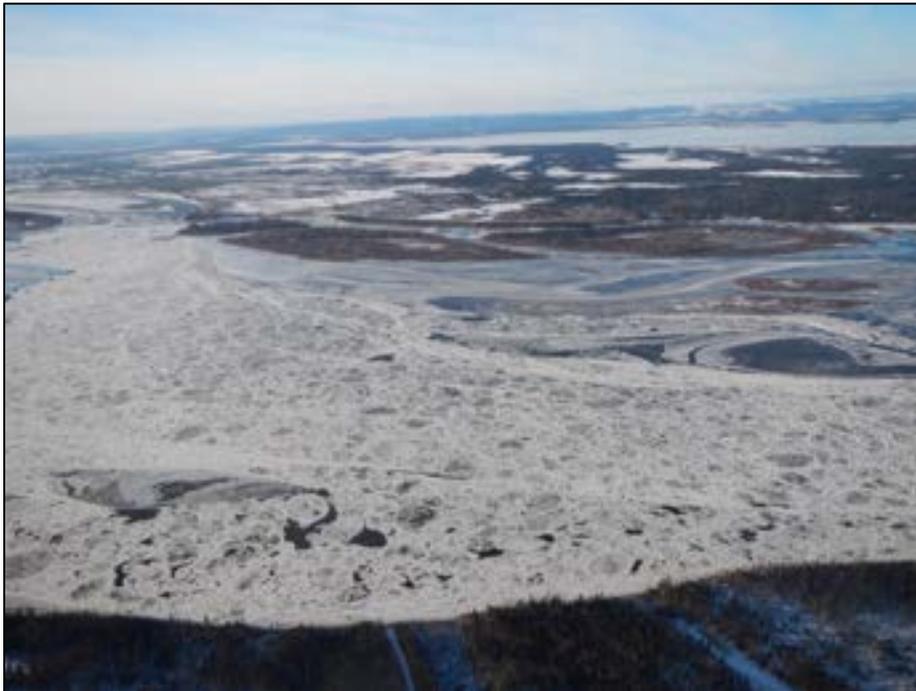
Figure 2.2 Example of a Photograph Taken From the Southern Bank of the Lower Churchill (Side View).

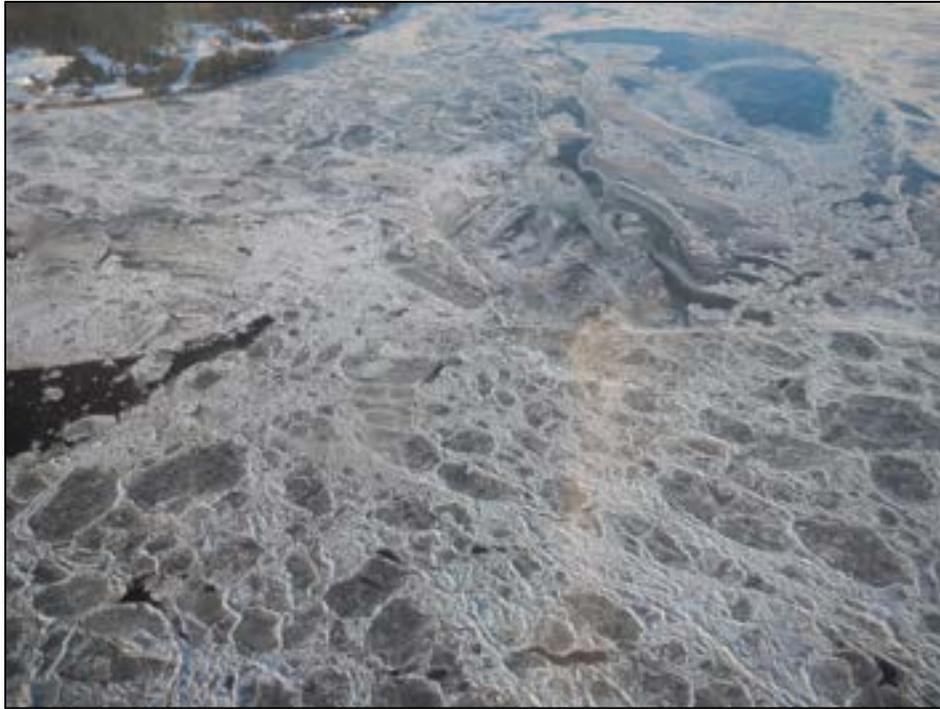
Figure 2.4 Mud Lake Ice Crossing Route, February 2015.

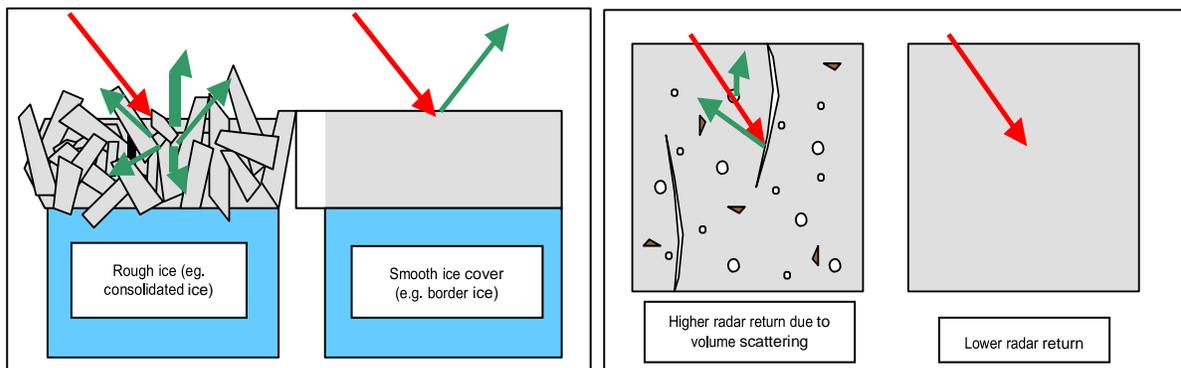
Radar satellites are active sensors in that they transmit a signal to the Earth's surface and record the energy reflected back to the sensor, as backscatter, and pixel intensity within the image is proportional to the backscatter. The sensor is side looking, so most of the signal will be deflected away from the sensor on smooth surfaces such as smooth ice. Rough surfaces, such as found with an ice jam, will deflect the signal in all directions including back to the sensor, producing bright areas as seen in the images. Generally, surfaces with roughness or complex geometry have higher backscatter. Figure 2.5 depicts schematically, the surface scattering and volume scattering processes. In the surface scattering diagram, the ice surface roughness dictates how much of the incoming signal is deflected away from the satellite and how much is received. Areas of rough ice will cause more of the signal (backscatter) to be received by the satellite. These features are represented as white pixels in the image. Darker areas in images represent smooth surfaces where much of the signal is deflected away from the satellite. The second diagram illustrates how volume scattering occurs within ice containing air pockets and cracks.

Figure 2.5 River Ice Scattering Mechanisms (Pelletier and Hicks 2003).

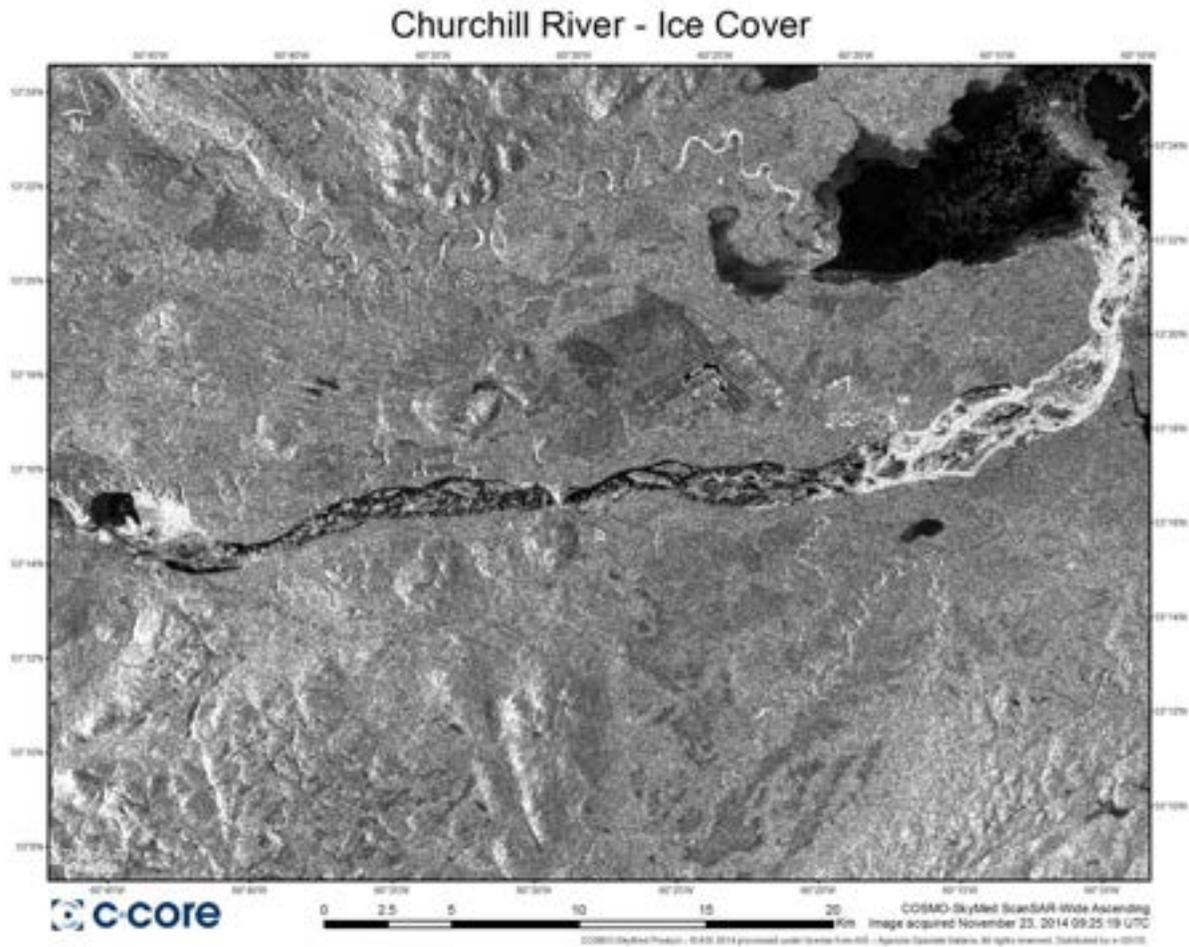
The Ice Cover product is a map containing the calibrated, visually enhanced, orthorectified SAR image. The darker sections of the river are areas of smooth ice or open water. They may also be pools of water on ice, depending on the time of year and the recent weather conditions. Smooth surfaces appear the same within a SAR image prior to image processing, such as those described above. Figure 2.6 shows an example of an ice cover product from the November 23, 2014, SAR image.

Figure 2.6 Ice Cover Product Created From the November 23, 2014, SAR Image.

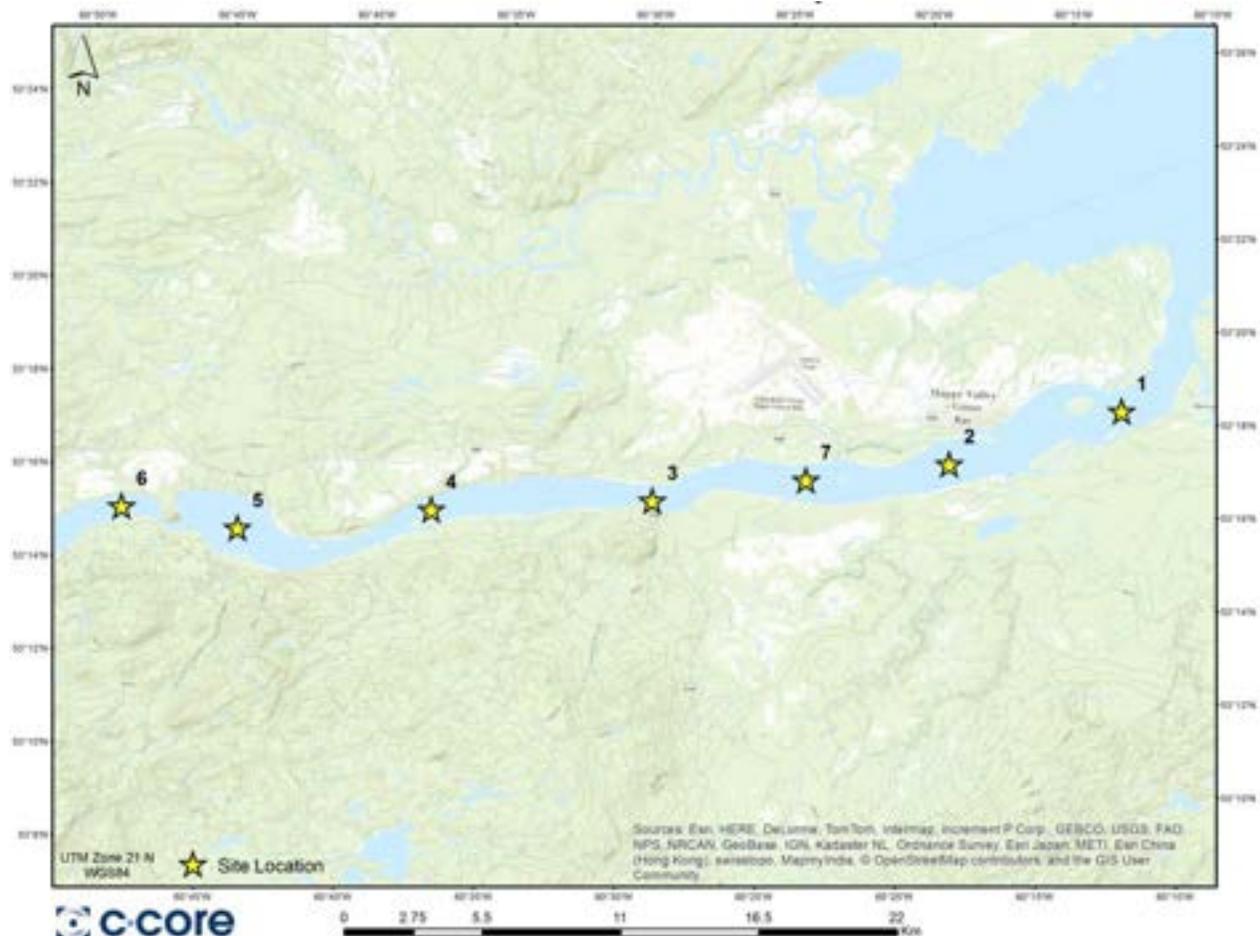
Figure 2.9 Photograph Locations During Freeze-Up and Break-Up in the 2014-2015 Ice Season.

An ice floe concentration analysis was performed on aerial photographs taken during the helicopter ice surveys (see Section 2.4) during freeze-up and break-up periods for the purpose of studying ice concentrations in the reach between Muskrat Falls and Mud Lake. Separate analyses were conducted for ice break-up and freeze-up periods. Photographs were chosen based on several factors including site locations that would represent as much of the river as possible, image clarity (glare and reflection) and photograph perspective. A total of 40 photographs were processed: 18 for freeze-up and 22 for break-up. The photograph sites chosen for break-up and freeze-up are similar, with the purpose of studying the changing ice cover at the same locations. Figure 2.9 shows the locations where selected photographs were

collected for the analyses. The photographs analyzed and the interpreted products, during freeze-up and break-up are provided in Appendices E and F, respectively.

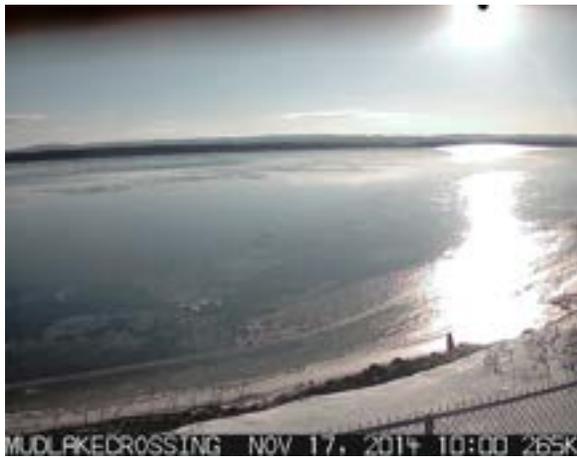
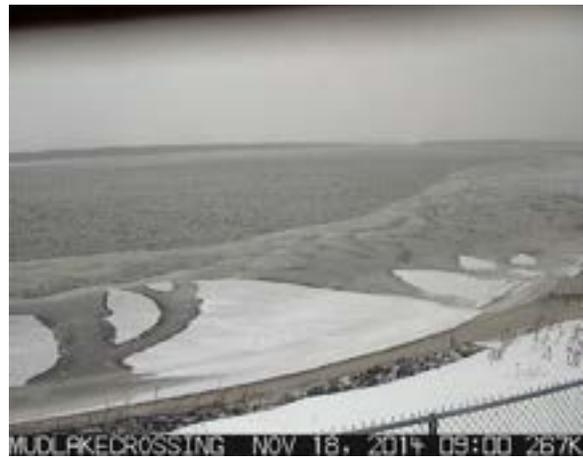
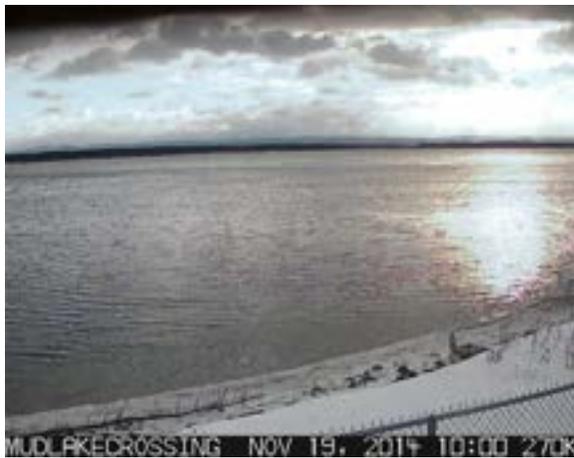
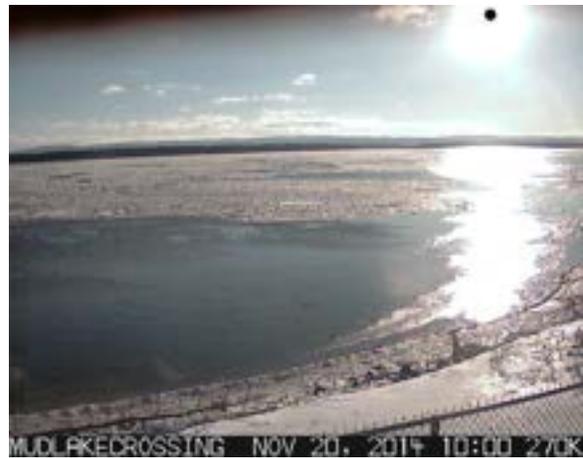
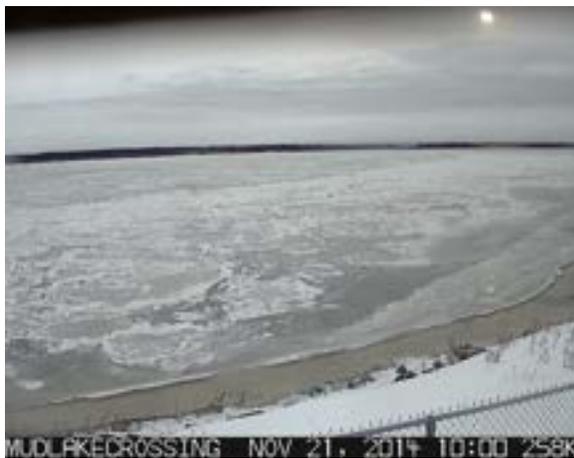
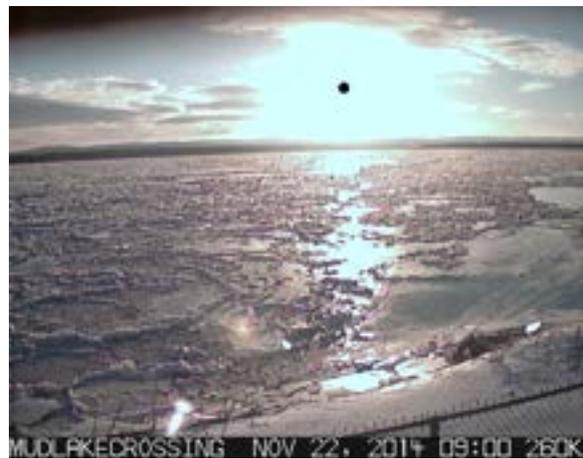
The freeze-up sequence for the period from November 17 to 28, 2014, is shown in Figures 3.1 and 3.2. Open water conditions were recorded at the web camera site on November 17, with ice developing along the river margins on November 18. Increasing concentrations of ice arriving from upstream locations were observed on November 20, with concentrations increasing over the period from November 20 to 24. The ice bridge crossing was considered formed on November 24, and Mud Lake residents began delineating the crossing on that date, which was the first date for snowmobile crossing in the 2014-2015 ice season.

Figure 3.1 Mud Lake Web Camera Images During the Freeze-Up Process, November 17 - 22, 2014.

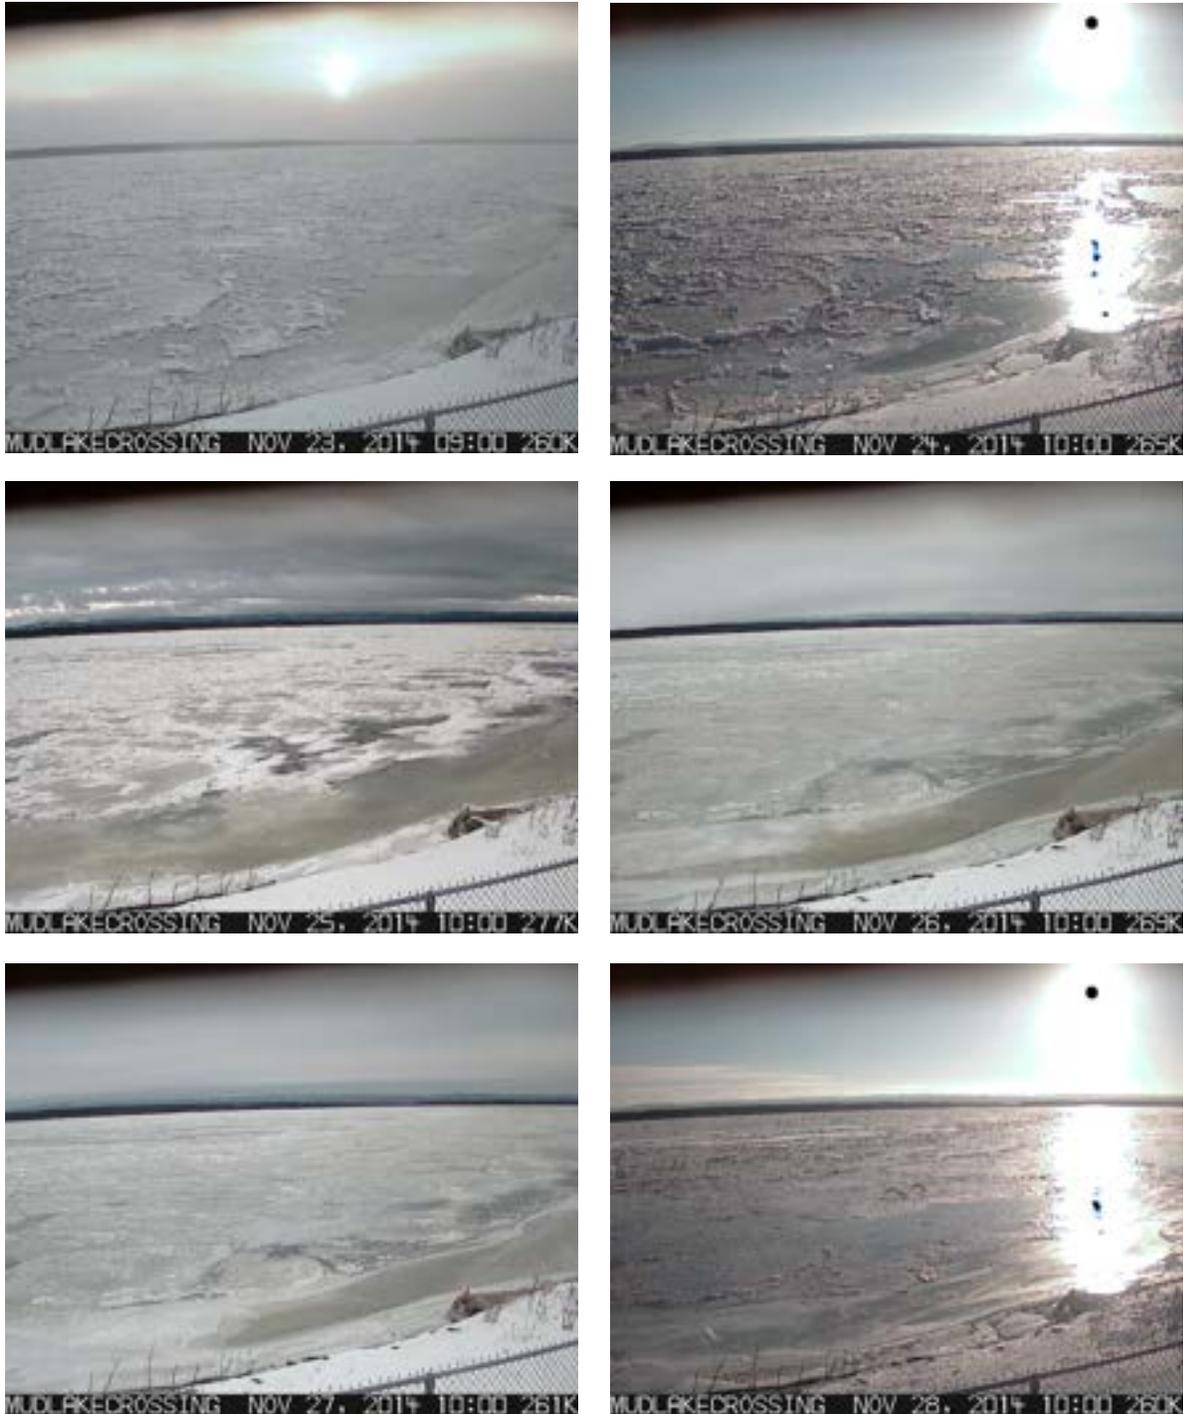
Figure 3.2 Mud Lake Web Camera Images During the Freeze-Up Process, November 23 - 28, 2014.

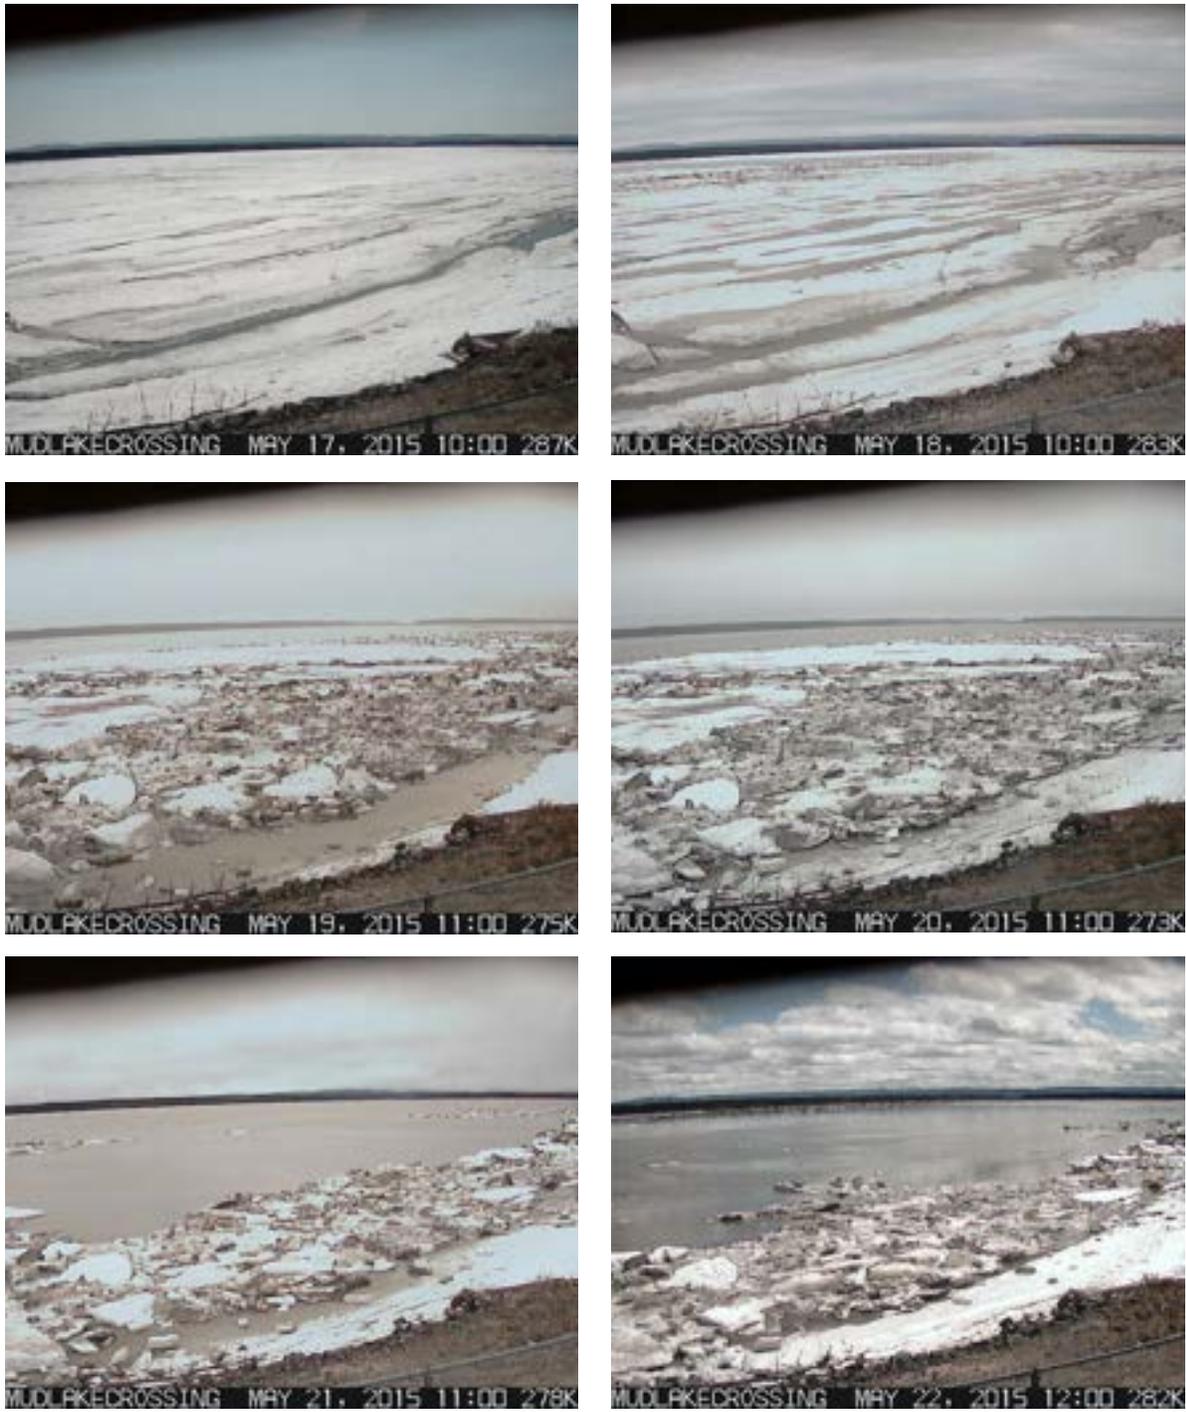
Similarly, the break-up sequence for the period from May 5 to 22, 2015, is shown in Figures 3.3 and 3.4. The images from May 5 through 8, demonstrated that the river was still frozen over completely with some melting areas first starting to appear on May 14 and 15. From May 15 to 18, open water sections became evident with increasing amounts of open water appearing over this period. There were extensive areas of open water on May 18 and 19. The river was free of large ice pans by May 19, with some ice rafting on the river margins. The amount of rafted ice decreased incrementally from May 20 to 22. The date of first crossing by boat was May 18. The duration of the break-up was about five to seven days, which is consistent with observations from previous years and as reported by SNC-Lavalin (2012a) for 2012 (six days) and for 2014 (seven days, SEM 2014).

Figure 3.4 Mud Lake Web Camera Images During the Break-Up Process, May 17 - 22, 2015.

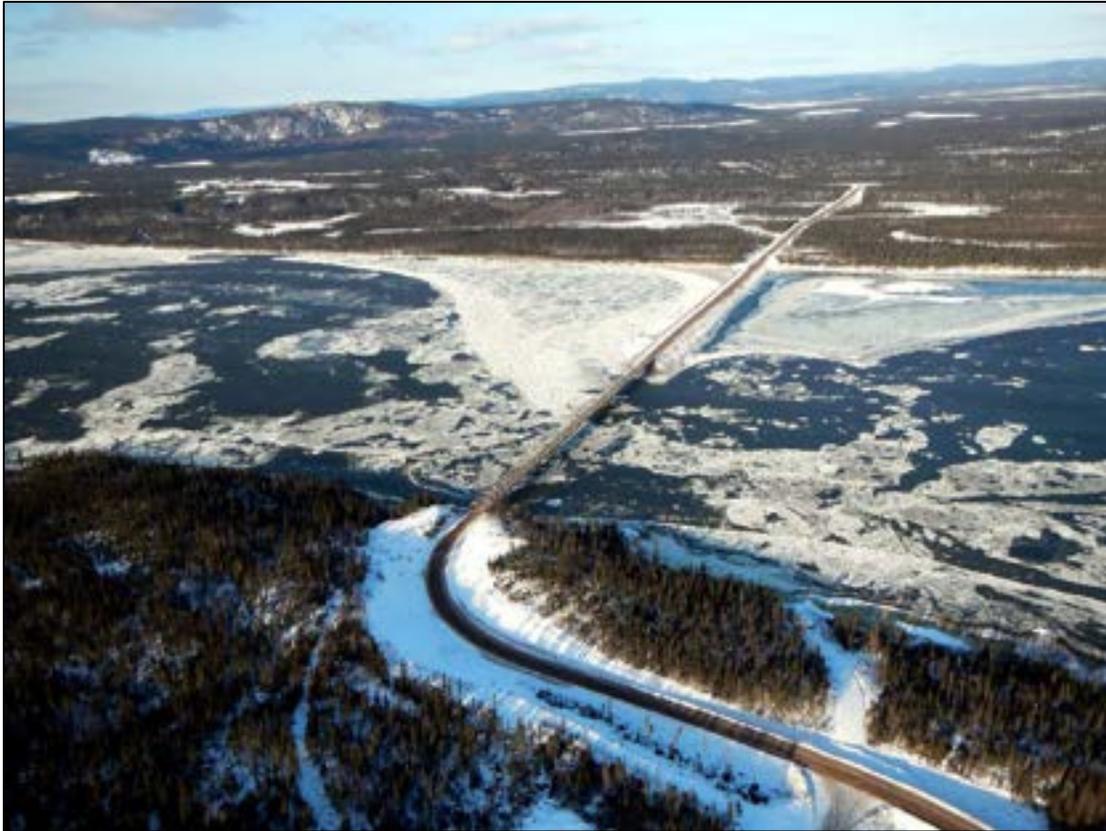
Figure 3.5 Example Photograph from the Aerial Ice Survey.

The results included a processed image with ice cover and open water classes with their respective area of coverage. Only the portion of the river where ice was flowing was classified, and border ice was not included. The analysis was performed using a Fuzzy K Means classification algorithm (Bezdek 1973) with an image mask isolating the classification to the river and areas of the river where separation between water and ice was possible. Filters were used to remove isolated, classified pixels. Figure 3.5 shows an example photograph and Figure 3.6 shows the resulting classification.

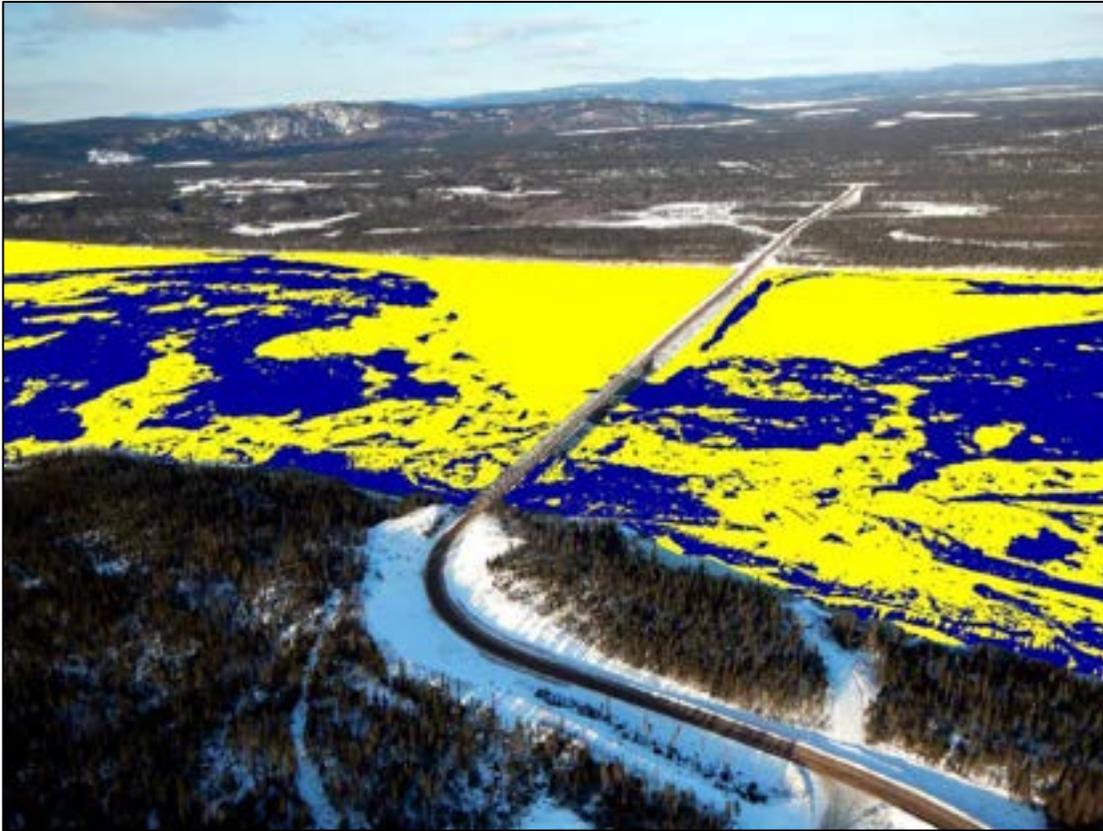
Figure 3.6 Example of a Classified Photograph from the Aerial Ice Survey.

During the image analysis there were some issues encountered. Reflections of vegetation on open water, shadow from overhanging banks and trees along the river, limited visibility caused by fog and photographs taken looking towards the horizon caused difficulty during classification. As a result, some images could not be processed to accurately distinguish between water and ice in some areas.

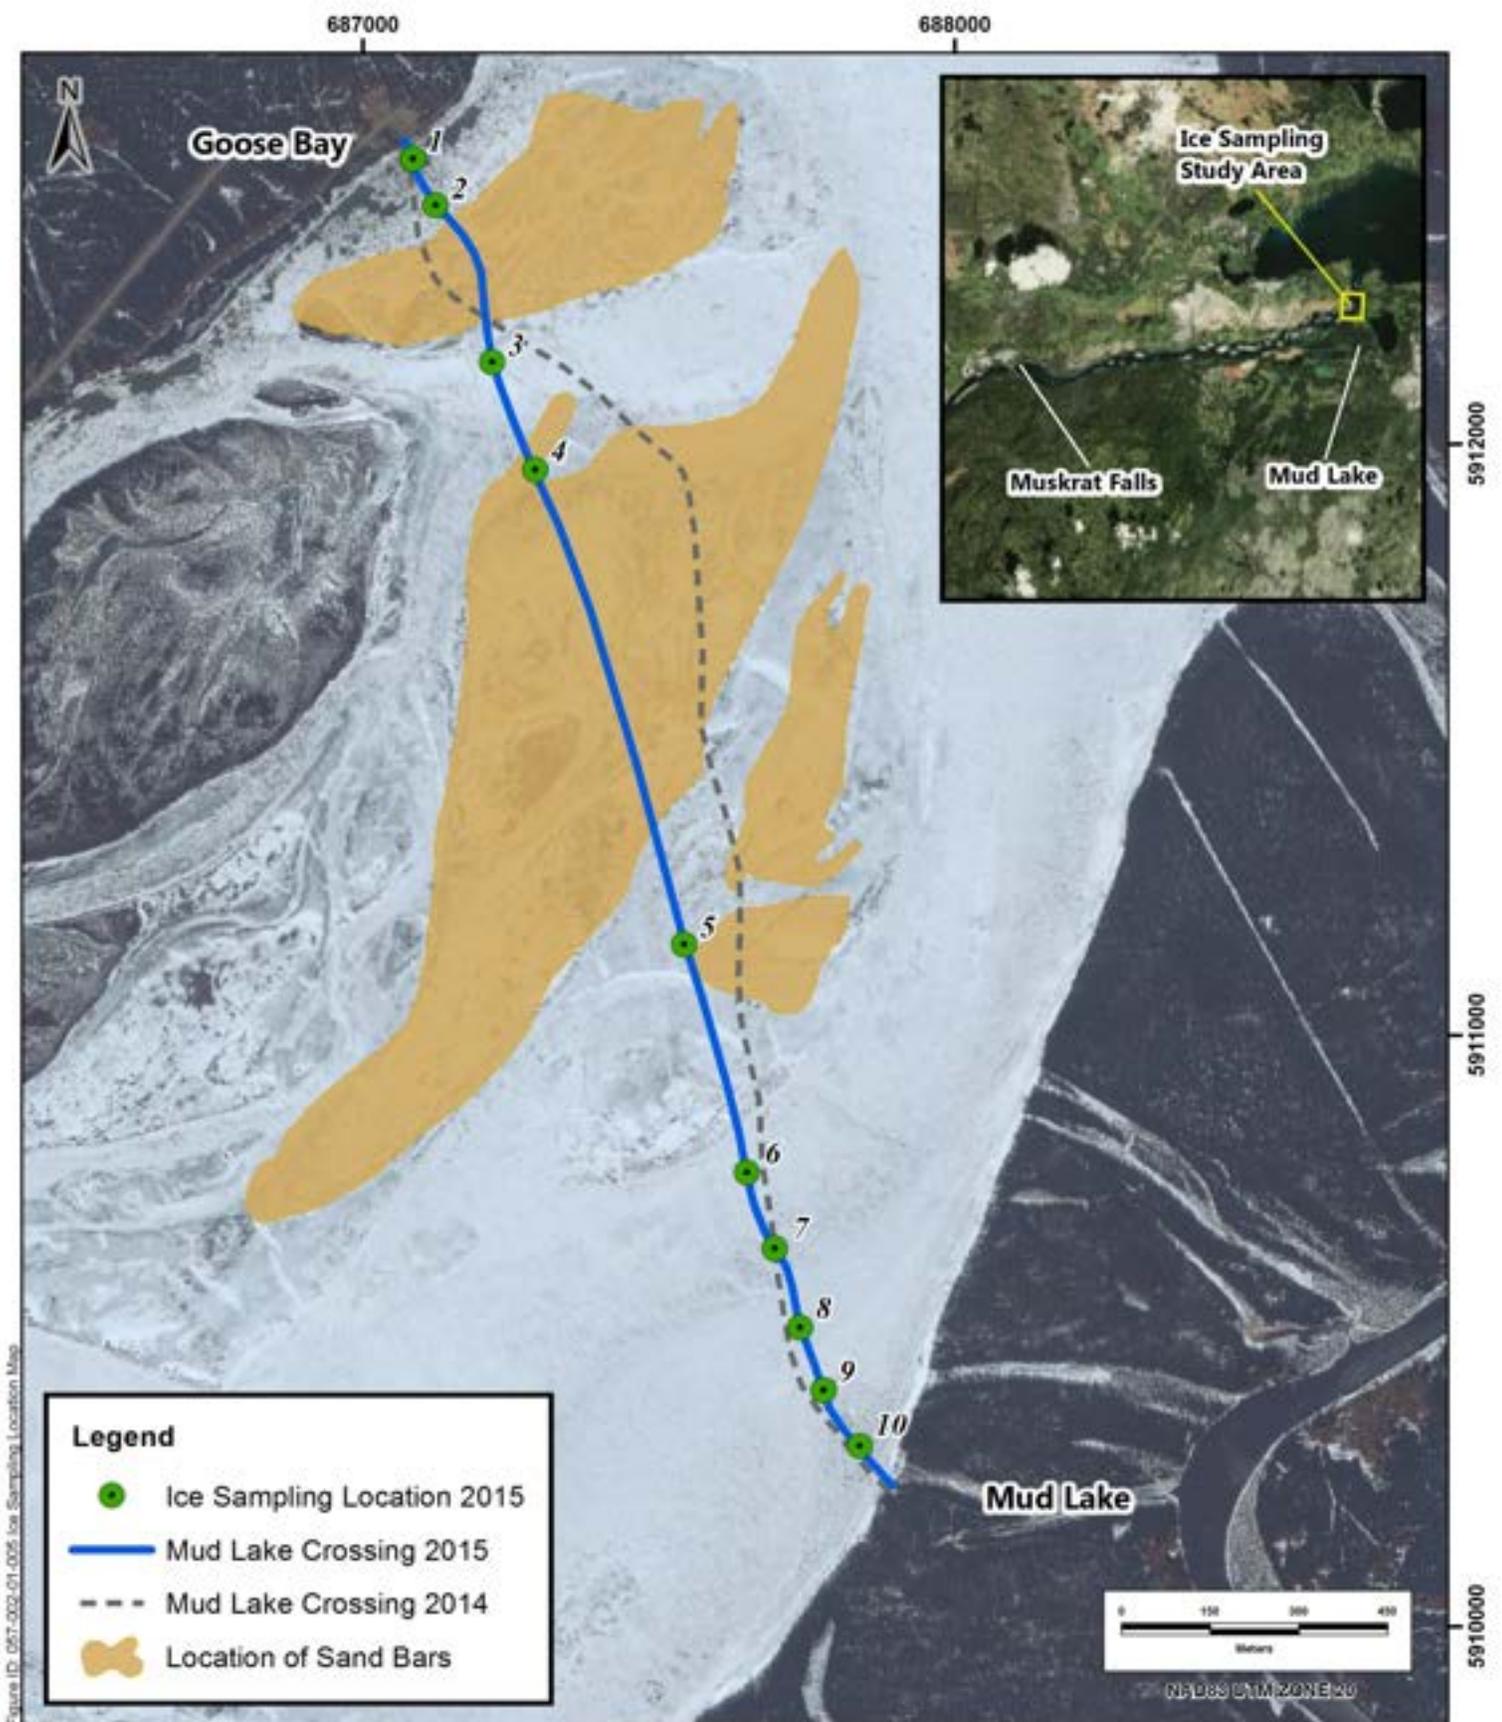
Figure ID: 0517-000-01-005 Ice Sampling Location Map

An ice thickness measurement and core interpretation survey was completed between February 9 and 10, 2015. A total of ten locations were augured along the ice crossing route as delineated by Mud Lake residents (Figure 3.7). The SEM team followed the delineated ice crossing route used by Mud Lake residents and collected ice thickness measurements at these ten locations. Sample sites were located a safe distance from the route so as to not obstruct traffic or cause any safety concerns, but close enough to get a good representation of the ice conditions along the route.

Holes in the ice were drilled using a gasoline powered auger. At each location the ice thickness was measured with a tape measure and a description of the ice condition recorded. Thickness measurements and associated notes are provided in Table 3.4.

The ice thickness from the ten locations was variable, averaging 82.6 cm \pm 10.7 (Std. Dev.), ranging from 65 to 100 cm and was solid throughout. Snow cover was considerable, ranging from 20 to 118 cm. In comparison, ice thickness in 2014 averaged 85.9 cm, was much more variable ranging from 45 to 120 cm, and at many locations ice was considered to be soft and slushy (SEM 2014). Snow cover in 2014 ranged from 10 to 70 cm and there was a slush layer below the snow ranging from 0 to 50 cm. The consistent thickness and solid ice condition in 2015 was attributed to the extreme cold conditions and good snow cover.

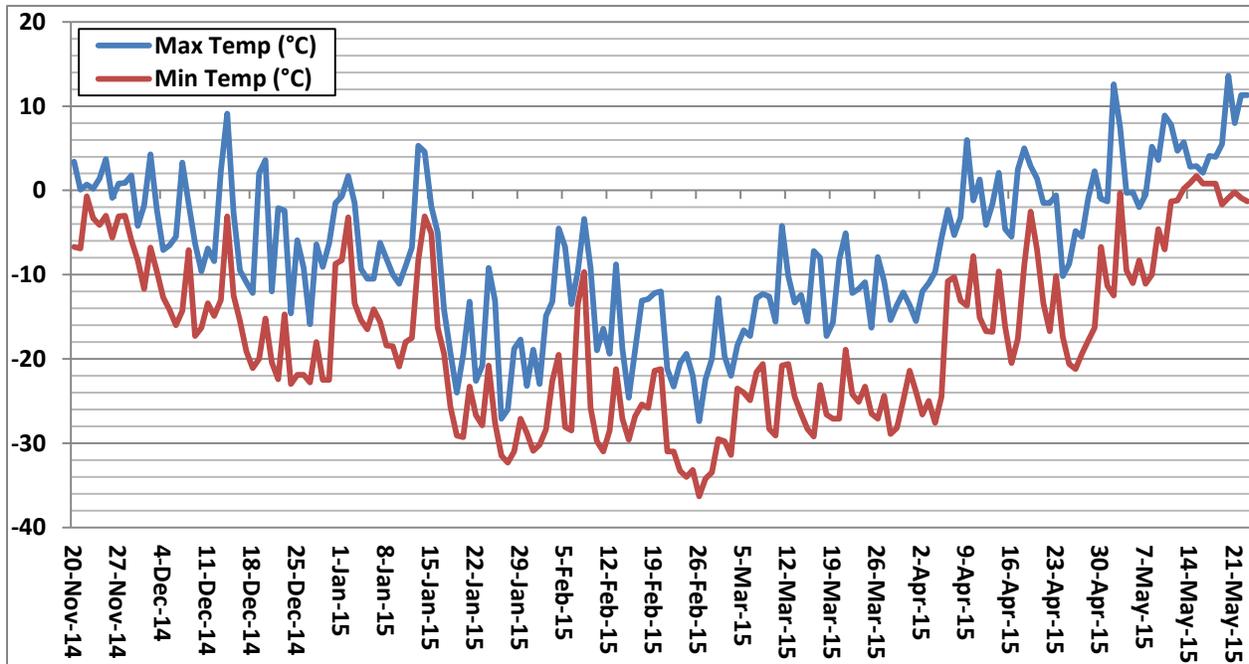
Figure 3.8 shows daily minimum and maximum air temperatures between November 20, 2014, and May 23, 2015. SAR image analyses determined that a correlation existed between lower backscatter from ice features and warmer air temperatures. The image analyses for December 1, 2014, for example, found the ice appeared brighter than on November 28, 2014, due to warmer temperatures on November 30, and December 1, 2014. This trend was observed again later in the ice season with the April 14, 2015 image, due to temperatures reaching 12°C the previous day. Warmer temperatures cause surface ice to melt, reducing the roughness of the ice surface, and therefore, reducing the amount of backscatter received by the satellite. Subsequent cold temperatures will freeze any water on the ice surface, increasing backscatter.

Figure 3.8 Daily Minimum and Maximum Air Temperatures During the 2014-2015 Ice Season.

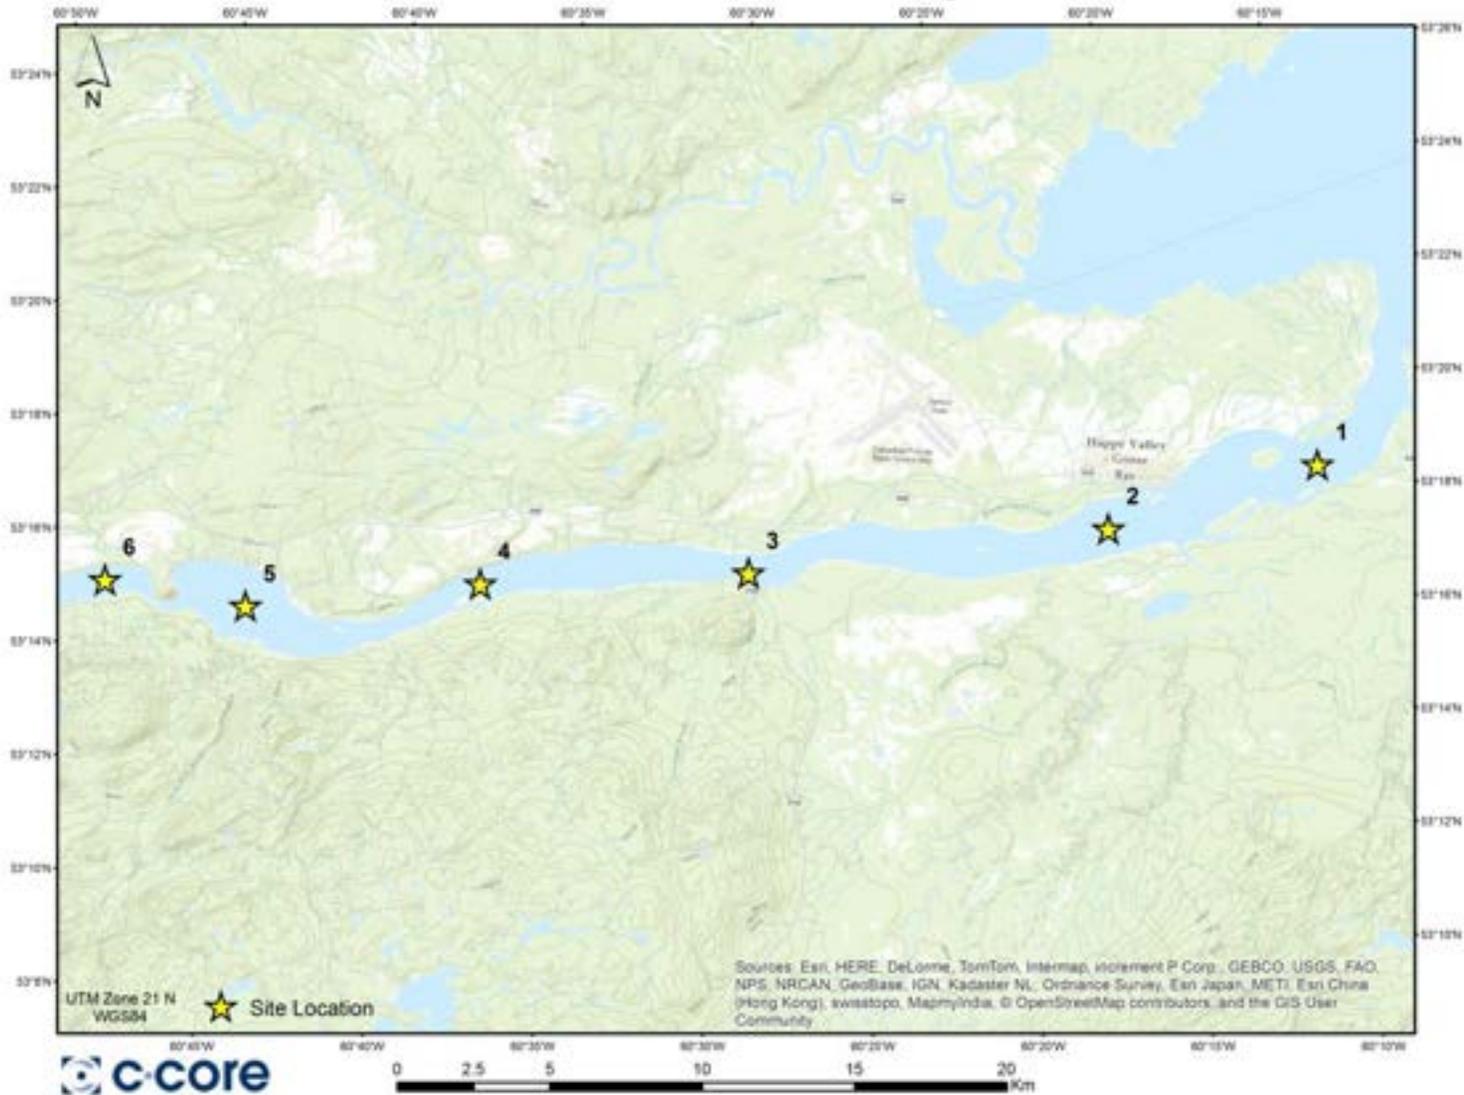
Churchill River - Aerial Photo Analysis 2014-15

An ice floe concentration analysis was performed on 40 aerial photographs taken during helicopter ice surveys during freeze-up and break-up periods for the purpose of studying ice concentrations in the reach between Muskrat Falls and Mud Lake. A total of 40 photographs were processed: 18 for freeze-up and 22 for break-up. Photos were selected based on several factors including site location that would represent as much of the river width as possible, image clarity (glare and reflection), and photo perspective. The photo sites for break-up and freeze-up were similar, as the objective was to document changing ice conditions at the same locations.

Aerial surveys were conducted on November 22 to 25, 2014, and a total of 850 photographs were collected. From these, three were selected from each of the November 22, 23 and 25 surveys for analysis. Photographs were chosen to cover the same sections of the river every day to determine changing ice cover. The site locations from which photos were selected are provided in Figure 2.9 and Table 3.2 contains the results of the analysis. The ice and water coverage were calculated from the number of pixels in each photograph and presented as a percentage. The percent of ice cover increased from November 22 to 23 from (mean \pm Std. Dev.) $51.3 \pm 25.1\%$ ice cover to $57.3 \pm 29.0\%$ ice cover. The proportion of ice cover decreased
