**2014-2015 Ice Observation Survey
Mud Lake Crossing, Lower Churchill River
LC-EV-107**

Sikumiut Environmental Management Ltd.

August 28, 2015

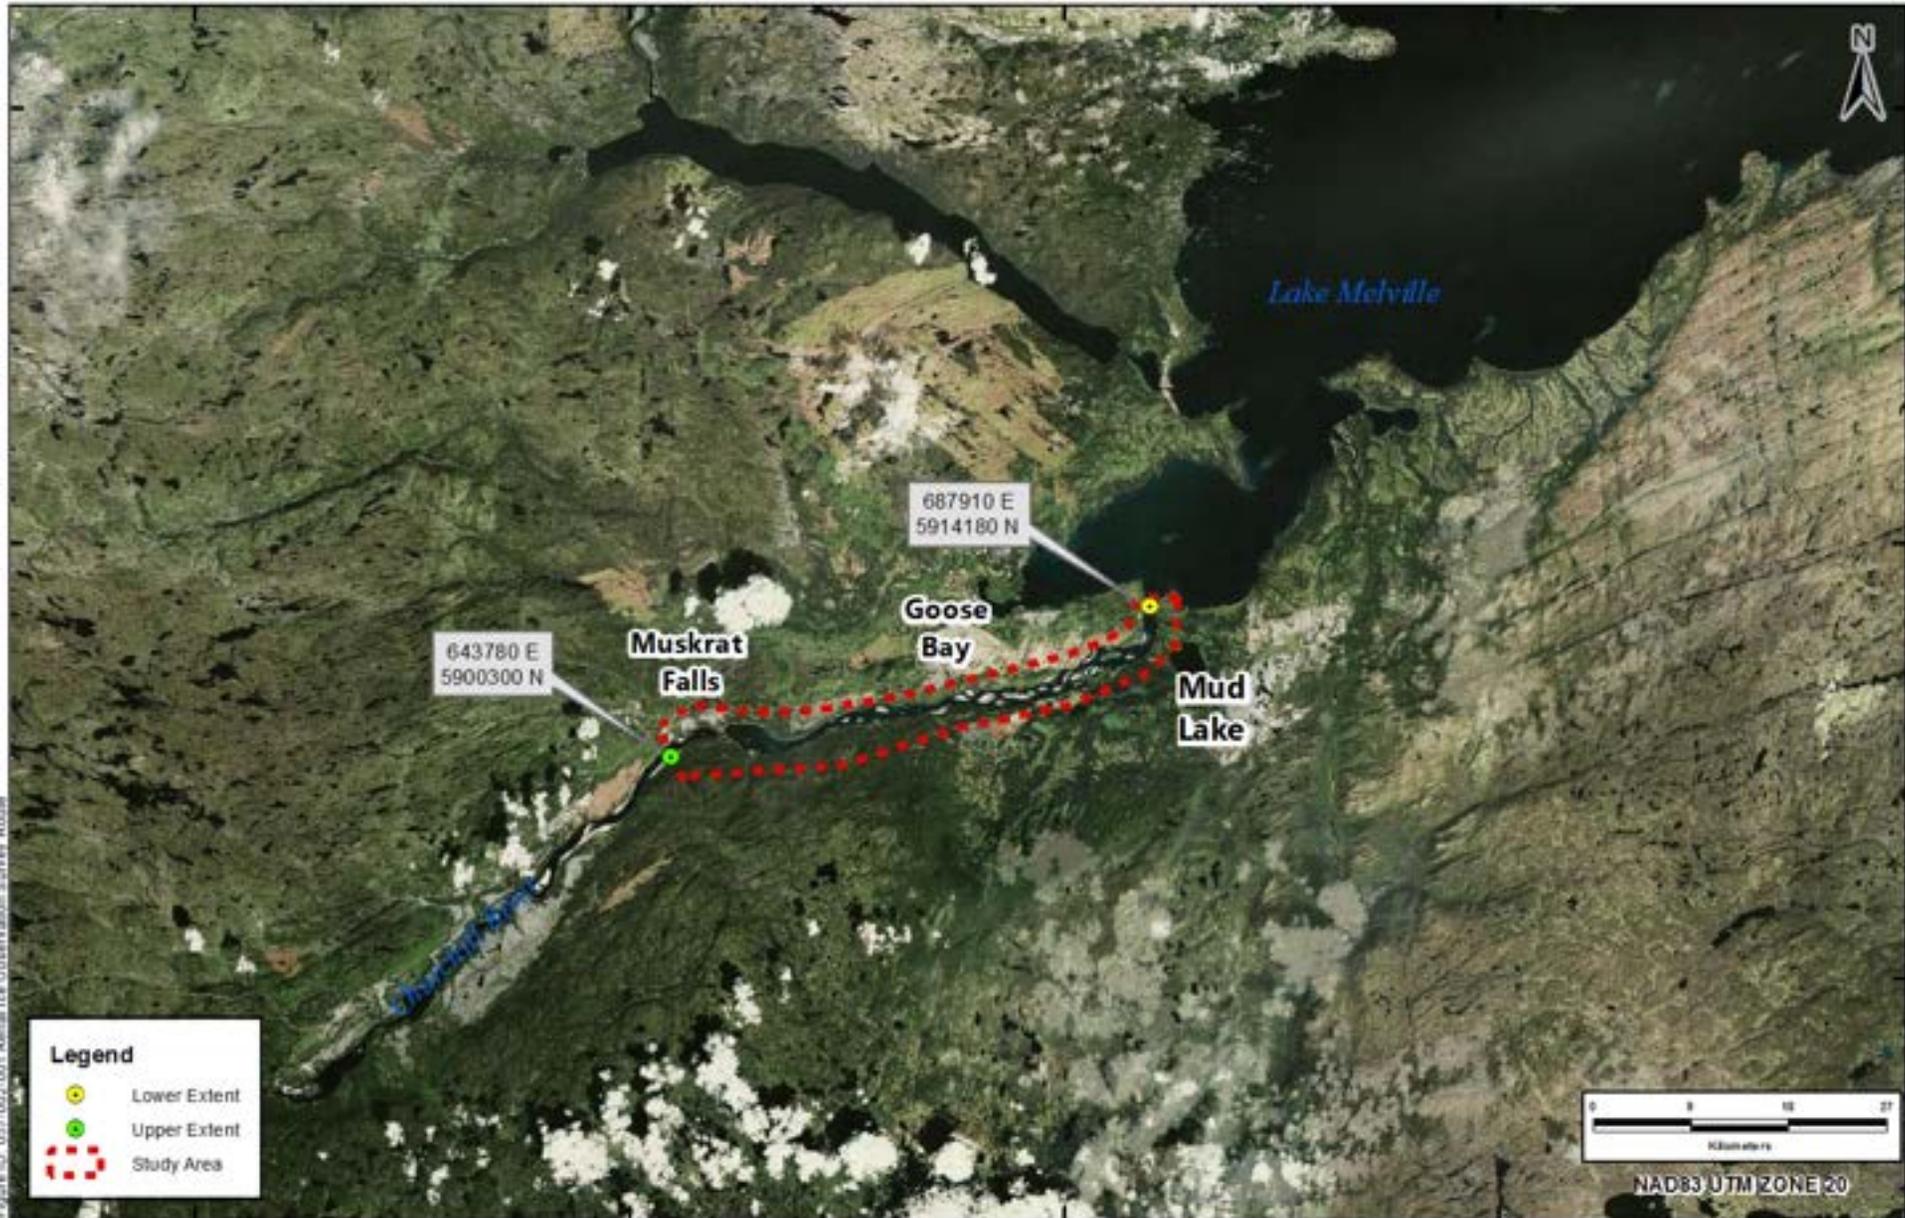
FIGURE NO:	3.1

Figure ID: 0517-0032-001 Aerial Ice Observation Survey Route

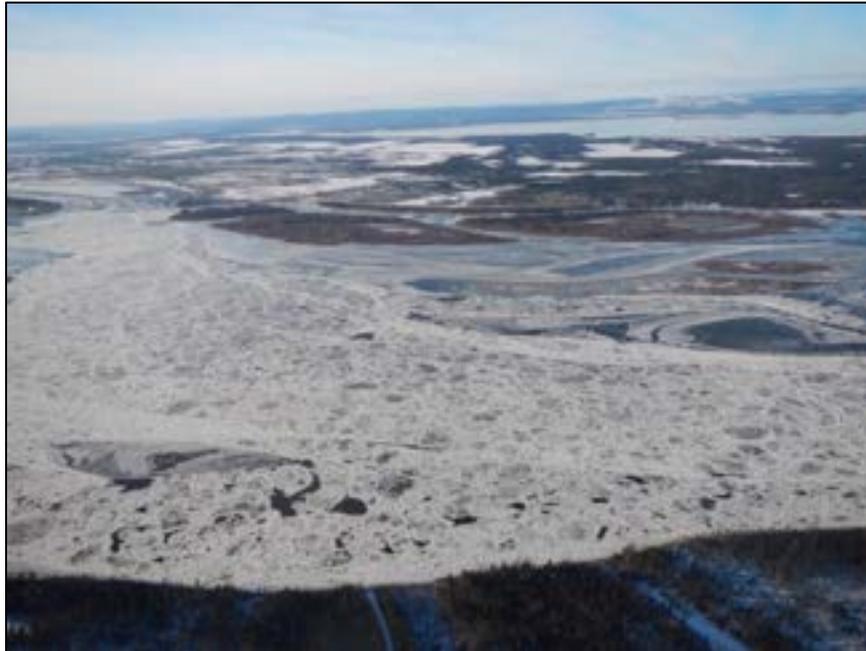
Figure 6.2 Photo from Southern Bank (Side View).

SEM initially conducted a toolbox safety meeting, followed by a detailed helicopter safety briefing provided by the pilot, Ken Cashin. The field team then departed from the Universal hanger at 13:55 and proceeded to fly to Mud Lake. The helicopter then flew along the southern bank of the Lower Churchill River and the SEM team took continuous side view photographs from Mud Lake to Muskrat Falls at approximately 300 meters above sea level (masl). An example of the side view photos is provided in Figure 6.2.

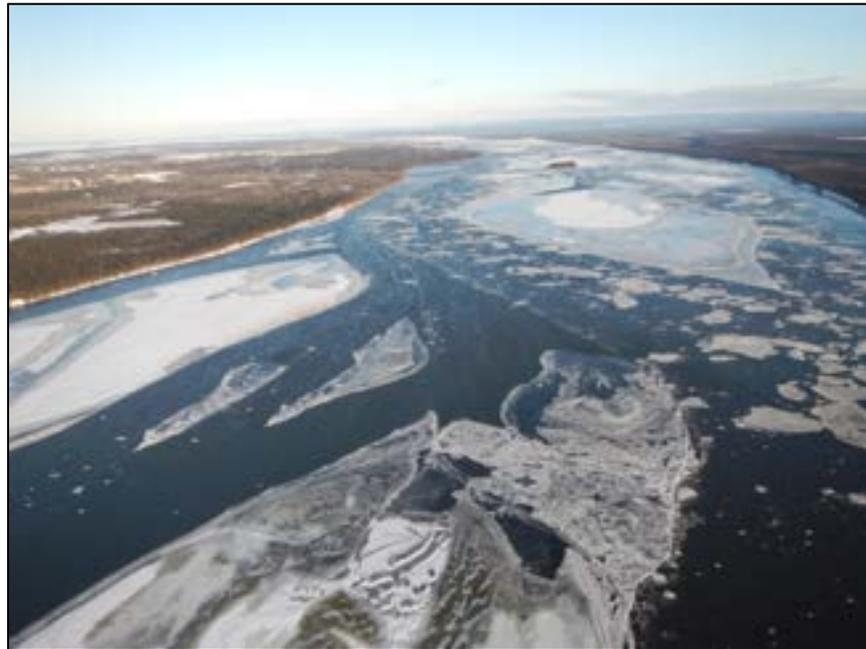
Figure 6.3 Photo from the Central Route (Bank to Bank).

On the return trip, the helicopter took a route down the center line of the river and SEM took photographs across the river, from bank to bank, in the same general locations as the previous survey, or if the field team deemed an area needed to be captured at approximately 300 masl. An example of a bank to bank photograph is provided in Figure 6.3. GPS locations were logged along the route at each photograph location to provide consistency between photos during the survey of the ice freeze-up and again during break-up. The two types of aerial photos (side view and bank to bank) were taken to ensure overlap, such that the entire extent of the river was captured. Once back at Mud Lake, more photographs were taken along the delineated ice crossing route.

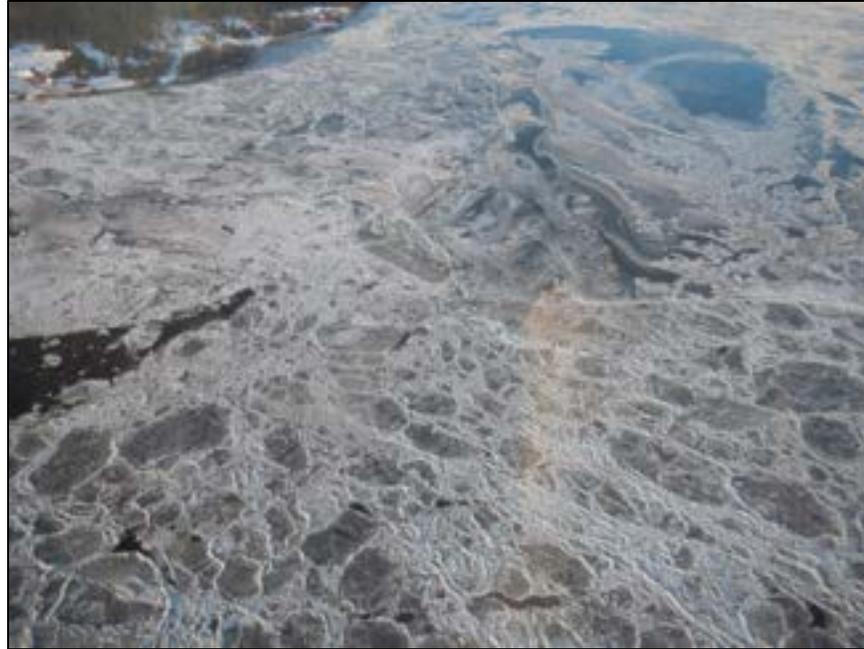
Figure 6.5 Mud Lake Ice Crossing.

The field team processed all data collected for the first two flights. It was noted that the ice seemed more competent and a suitable, safe snowmobile crossing could soon form. A telephone call between field lead and the SEM Project Manager was made to provide an update of weather and ice conditions. The Project Manager advised that the survey timing was appropriate for freeze-up and to continue with the scheduled surveys.

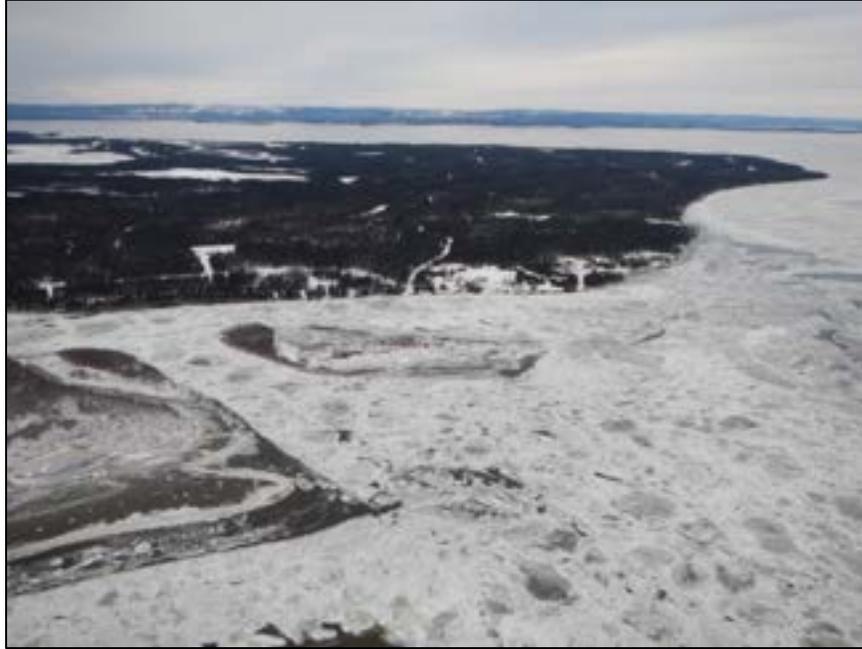
The condition of the ice near Mud Lake had improved and snowmobiles had begun crossing, from Mud Lake to Happy Valley–Goose Bay. It was noted that Mud Lake residents were out on the ice marking the trail with spruce tree tops for the season as done in previous years (see Figure 6.6).

Figure 6.6 Mud Lake Ice Crossing.

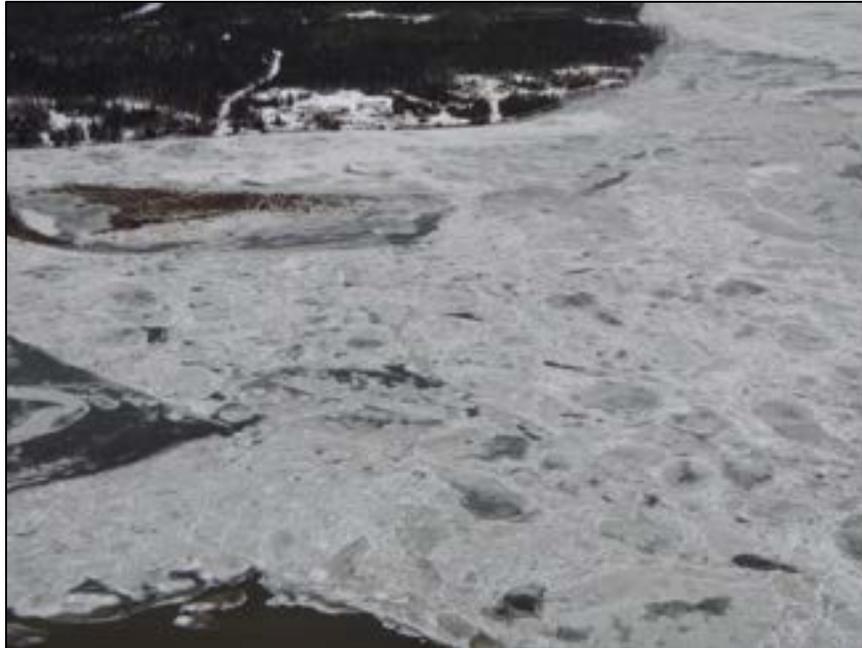
The field team returned to Mud Lake and took photos to document the condition of the Mud Lake ice crossing. The condition of the ice near Mud Lake still appeared competent (Figure 6.7) and one snowmobile was crossing at the time of the survey.

Figure 6.7 Mud Lake Crossing Overview from the South Bank.

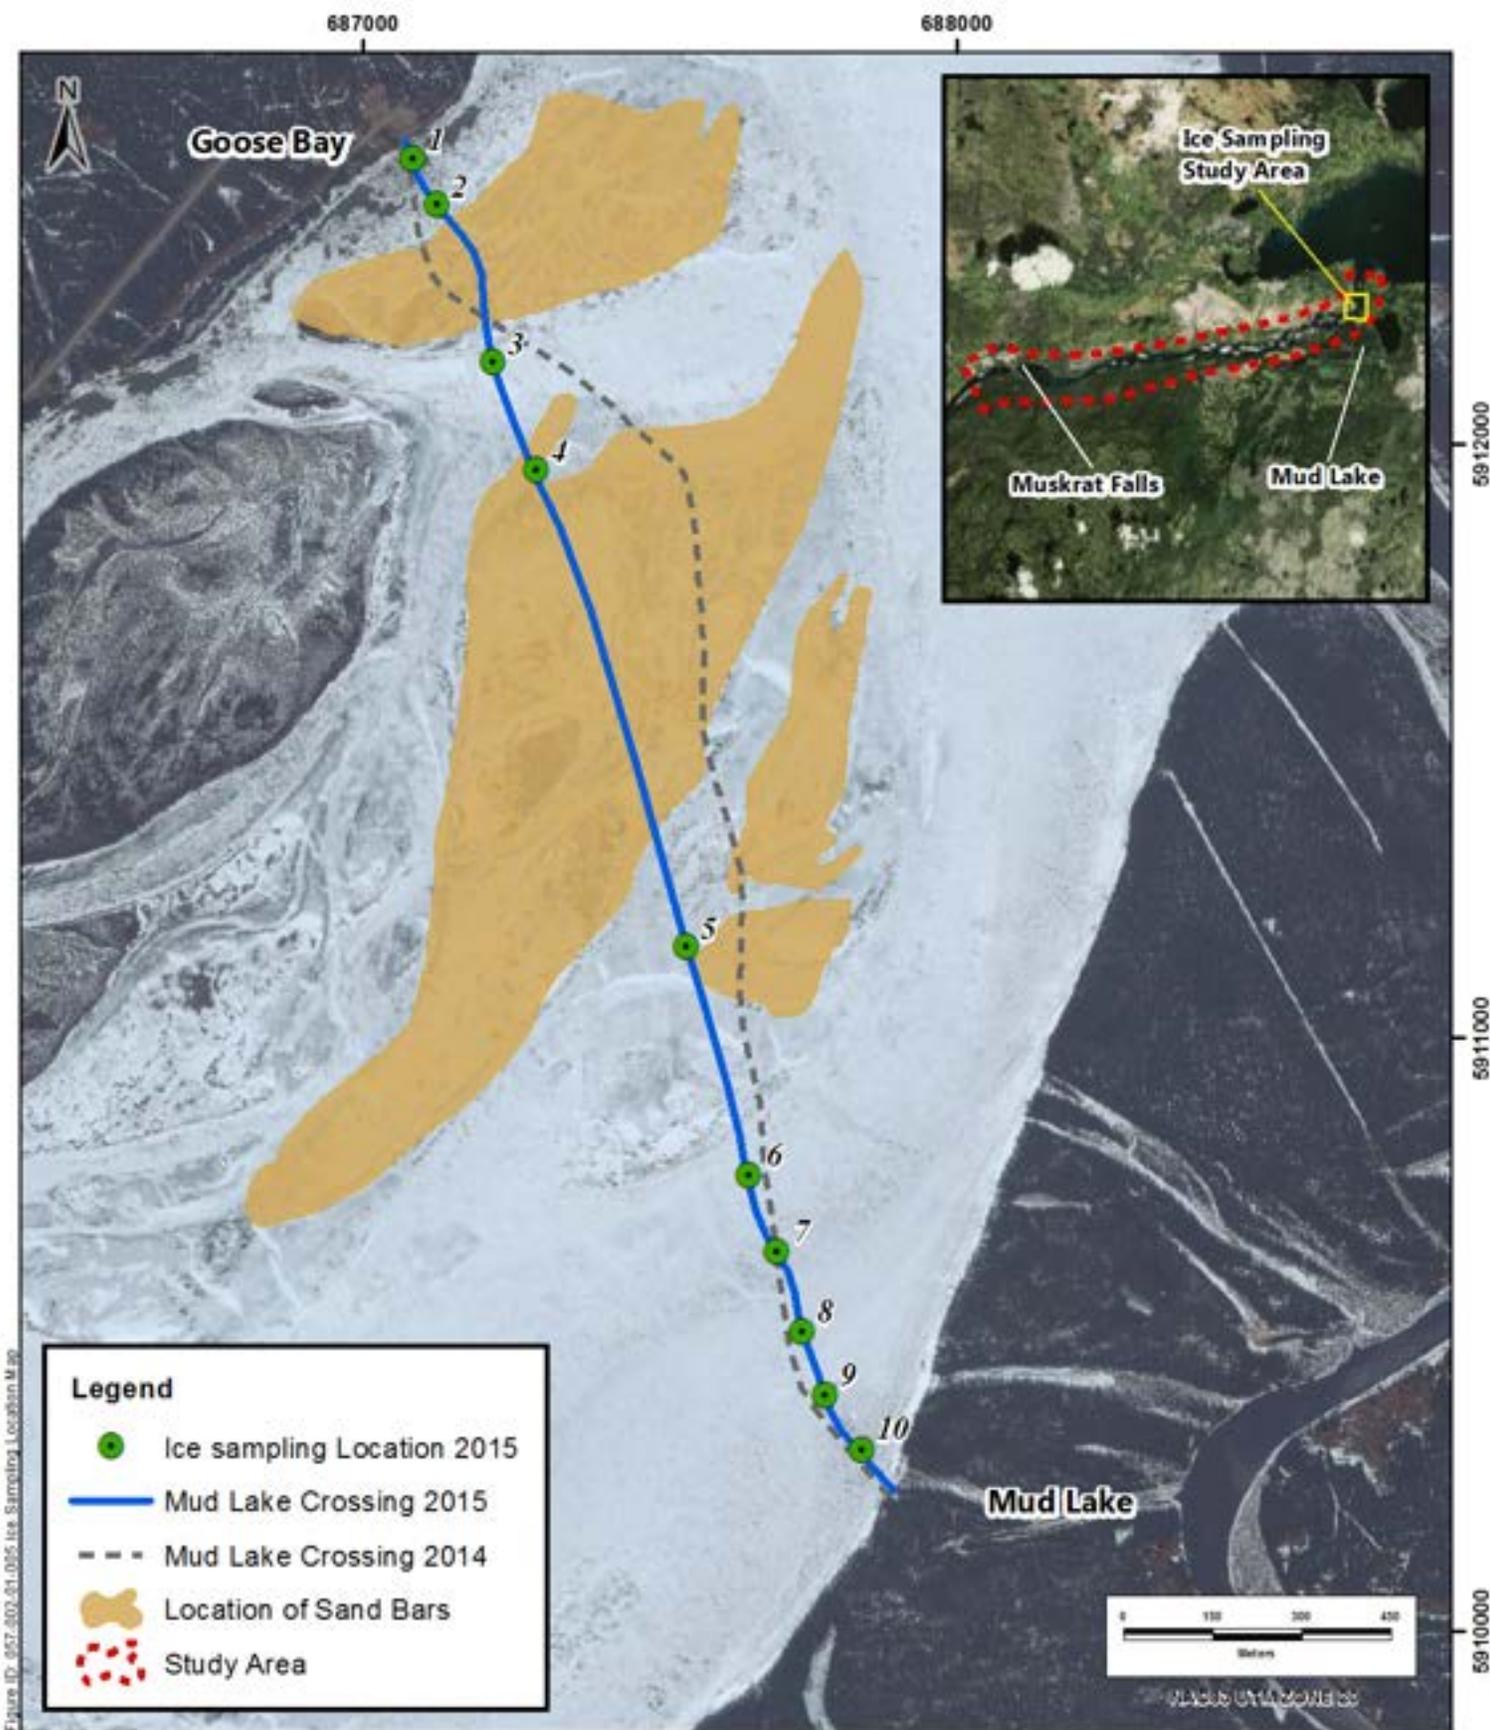
Figure ID: 657_000_01_005 Ice Sampling Location Map

The ten ice sampling locations were along the Mud Lake ice crossing route, which is approximately 2.5 kilometres (km) in length. The ice thickness varied from 70 to 118 centimetres (cm) with most auger holes having solid ice throughout, with the exception of one hole located just off the south bank of the river (Ice Sampling Location 10, Figure 6.8), which had a layer of slush 20 cm thick on top of the ice. All holes were snow covered with thickness ranging from 65 to 100 cm. All data collected is provided in Table 6.1.

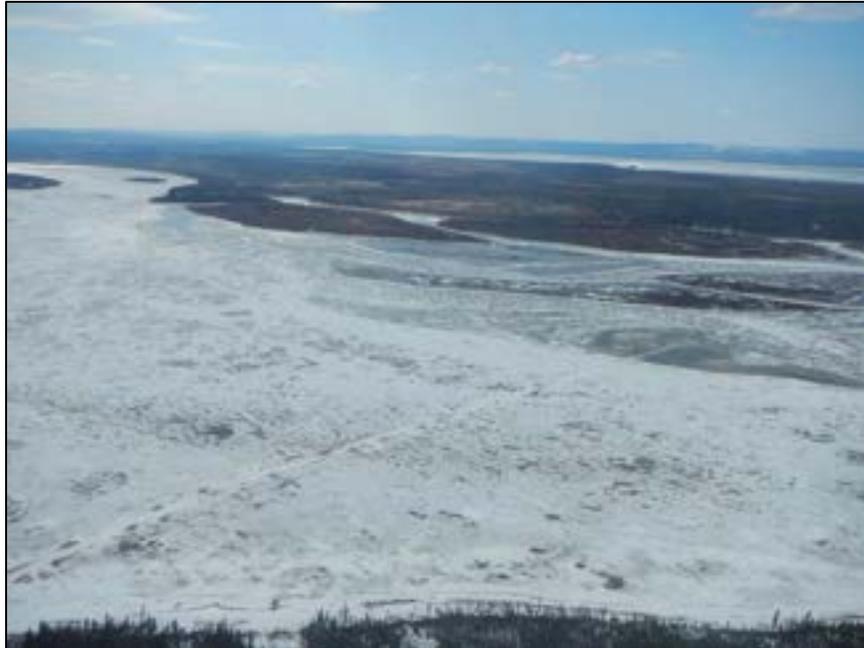
Figure 6.2 Photo from Southern Bank (May 17, 2015 Mud Lake Crossing) (Side View).

SEM conducted a toolbox safety meeting which was followed by a detailed helicopter safety video and a briefing provided by the pilot, Wayne Massie. The field team then departed from the Canadian hanger at 15:15 and proceeded to fly to Mud Lake (at the mouth of the Churchill River). The helicopter then flew along the southern bank of the Lower Churchill River and the SEM team took continuous side view photographs from Mud Lake to Muskrat Falls at approximately 250 metres above sea level (masl). An example of the side view photos is provided in Figure 6.2. On the return trip, the helicopter took a route down the centre line of the river and SEM took downstream photographs across the river, from bank to bank, in the same general locations as the previous survey using waypoints loaded into the handheld Global Positioning System (GPS) device. An example of a bank to bank photograph is provided in Figure 6.3. The centre line photos were taken at the same altitude as the side view photographs (~250 masl.). GPS locations were tagged to the centre line photos along the route at each location to ensure consistency between photos during the survey of the ice break-up and again during freeze-up. The two types of aerial photos (side view and centre line bank to bank) were taken to ensure overlap such that the entire extent of the river was captured. Figure 6.4 demonstrates the flightpath for the side view and centre line photographs. Once back at Mud Lake, photographs were taken at 150 masl along the delineated crossing area (Figure 6.5).

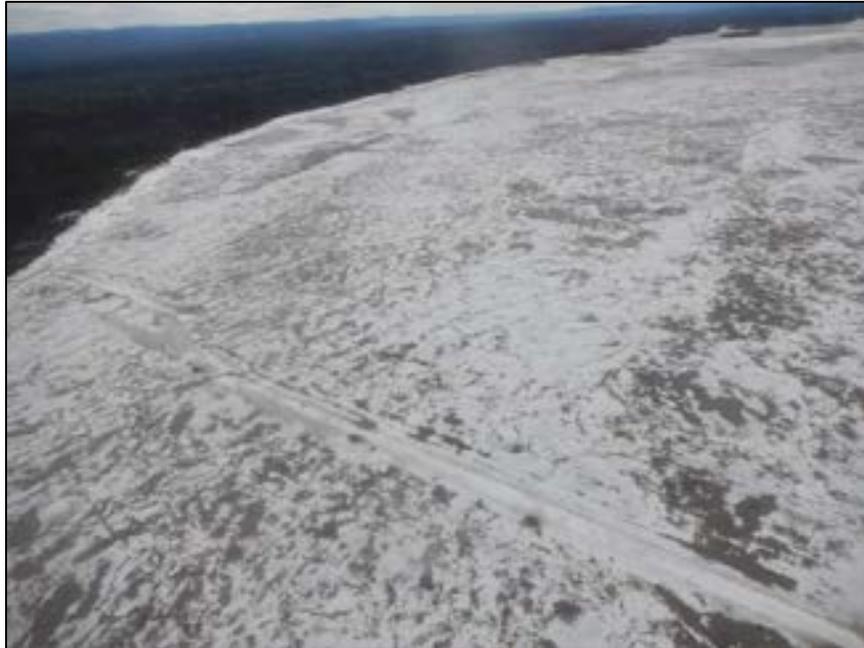
Figure 6.7 Mud Lake Ice Crossing (May 18, 2015).

The field team then flew to Mud Lake and followed the same route followed the previous day, up the southern bank of the Lower Churchill River to Muskrat Falls, and then returning down the centre line of the river back to Mud Lake, maintaining an altitude of 300 to 350 masl. Once back at Mud Lake, detailed photographs were taken along the delineated crossing area (Figure 6.7).

The field team processed all data collected for the first two flights. It was noted that there was already some change in the ice conditions from the previous day's survey.

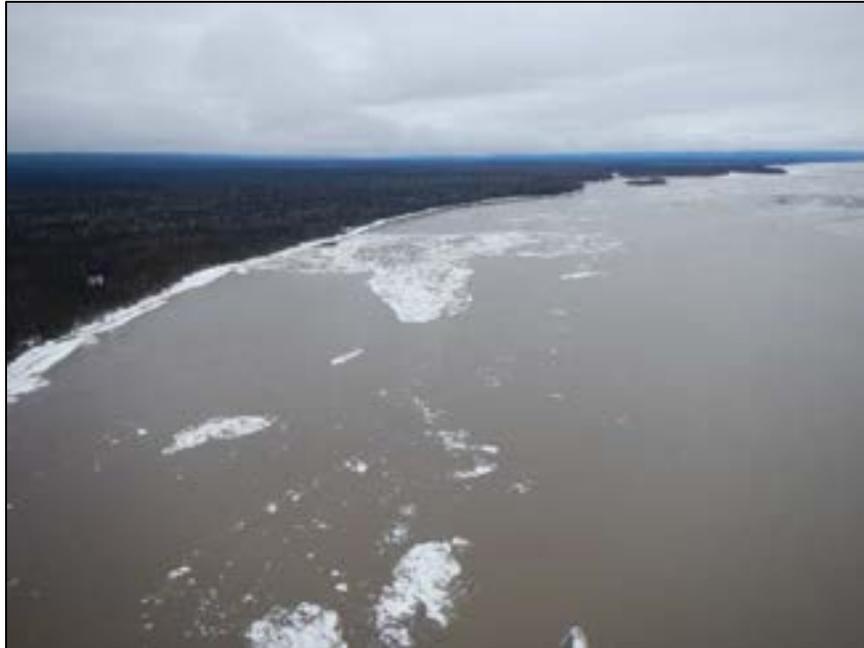
The field team returned to Mud Lake and continued to take overlapping photos along the length of the Mud Lake crossing, which was open water (Figure 6.9).

Figure 6.9 Mud Lake Ice Crossing (May 19, 2015).

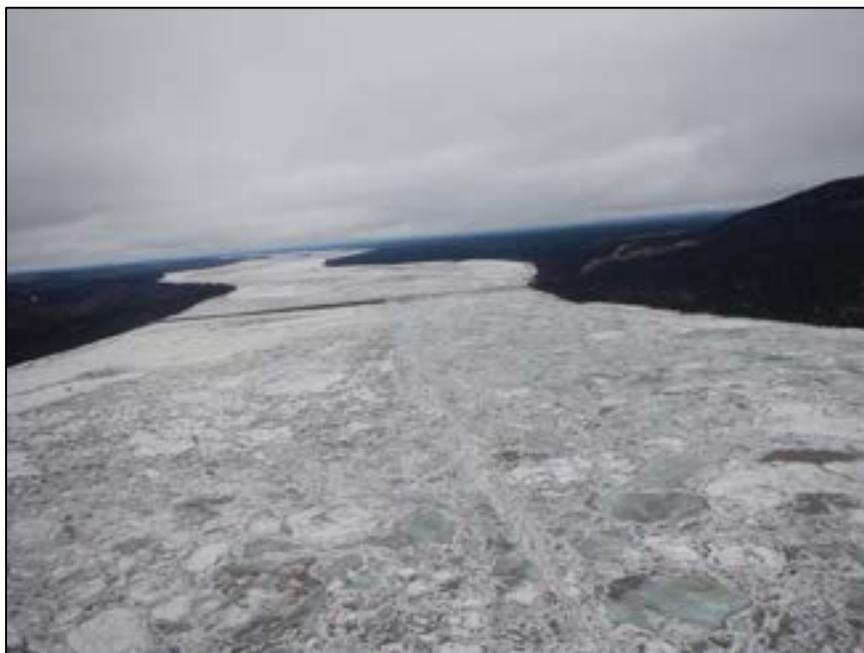
Most of the survey reach of the Lower Churchill River was open water with the exception of some ice accumulating near the causeway as well as just below Muskrat Falls (Figure 6.10).

Figure 6.10 Break-up Near Causeway (May 19, 2015).
