NE-LCP Contractor/Supplier	Contract or Purchase Number and Description: LC-EV-107		Contractor/Supplier Name: Golder Associates Ltd.		
	Document Title: 2018-2019 Ice Observation Survey Mud Lake Crossing, Lower Churchill River			Total Number of Pages Incl. Front Sheet 106	
	Contractor/ Supplier Document Number: 1670877-3000			Revision Number: C1	
	EPC(M) Document Number: Not Applicable			Issue Number: Not Applicable	
	NE-LCP Document Number: LCP-GA-CD-0000-EV-RP-0007-01			NE-LCP Issue Number: B2	
	Approver's Signature: Callie Andrews

**2018-2019 Ice Observation Survey
Mud Lake Crossing, Lower Churchill River
LC-EV-107**

Sikumiut Environmental Management Ltd.

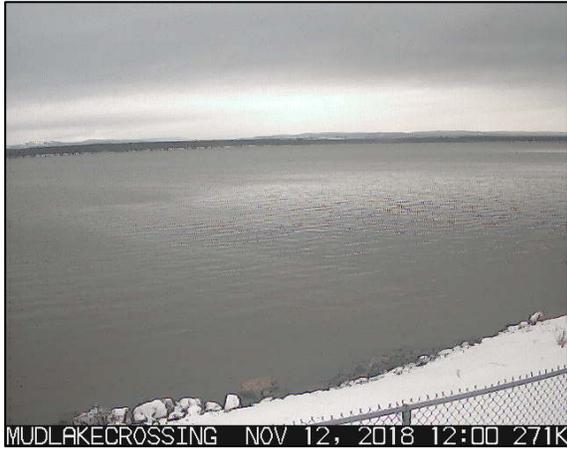
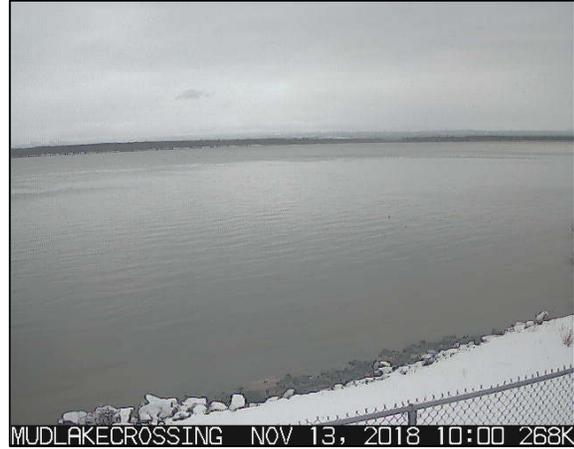
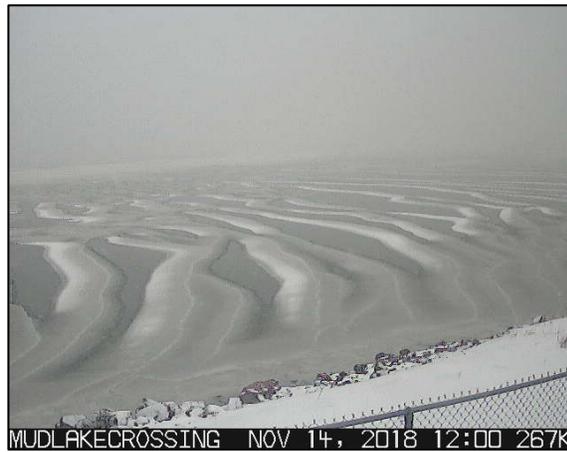
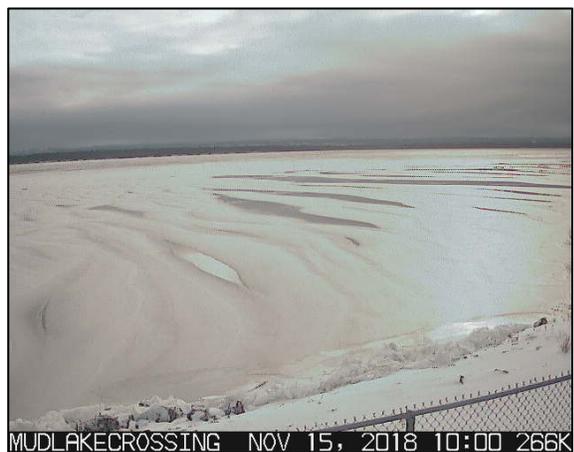
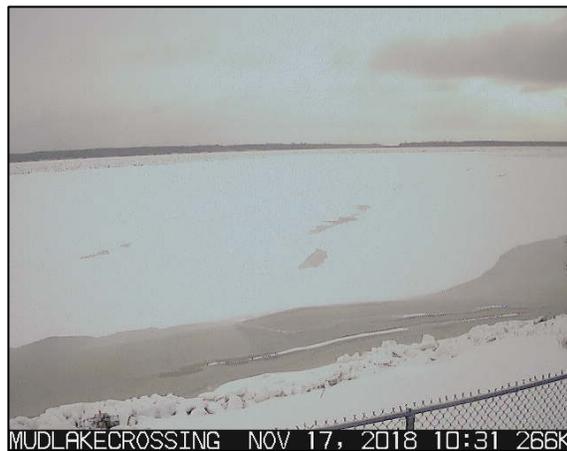
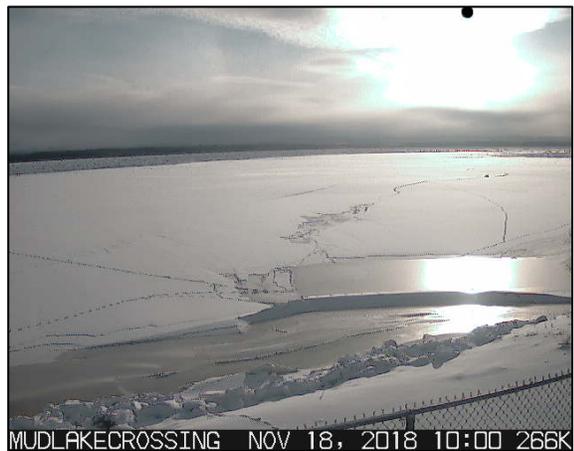
Figure 3.1 Mud Lake Web Camera Images During the Freeze-Up Process, November 12 - 18, 2018.

The freeze-up sequence for the period from November 12 to December 5, 2018, is shown in Figures 3.1 and 3.2. The river was ice free on images November 12 and 13 and surface ice first appeared by November 14. Ice formed quickly starting on November 14 and 15 with open water apparent on the north side of the river. The ice consolidated over the period from November 15 through 21 with rough ice apparent in the river center suggesting accumulation of ice that had formed upstream. The ice on the river margin further solidified over this period. The ice bridge was considered formed on November 21, 2018, the date of the first snowmobile crossing for the 2018-2019 ice season (Jordan Hope, pers. comm.).

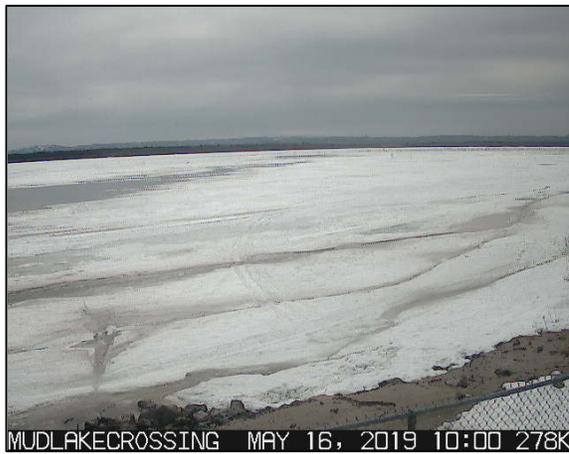
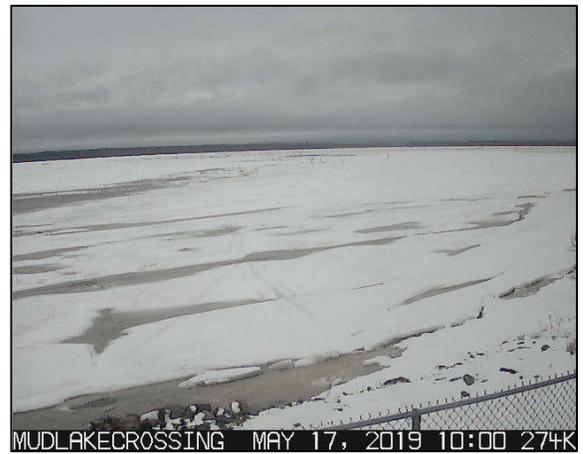
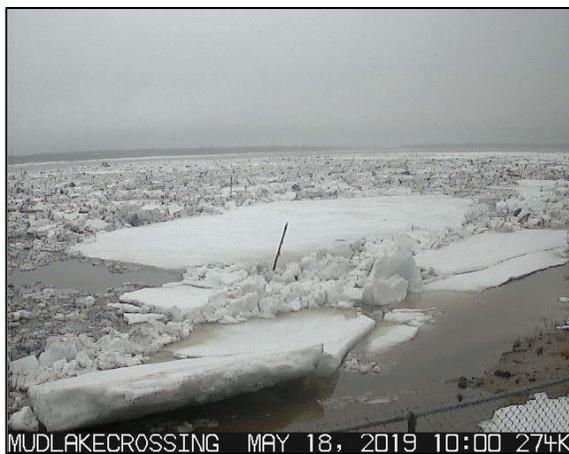
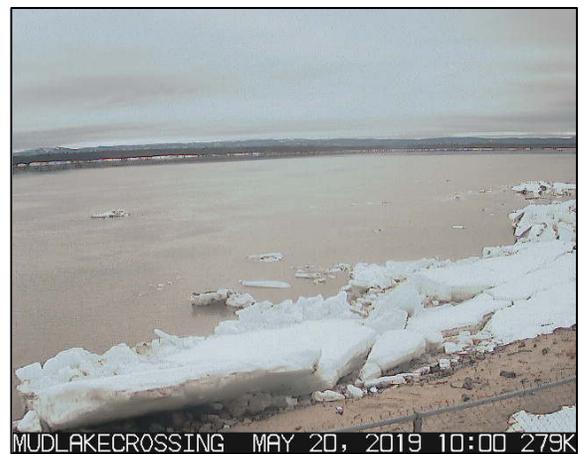
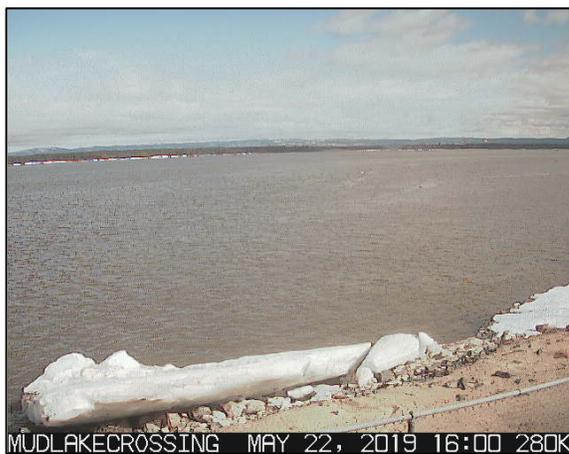
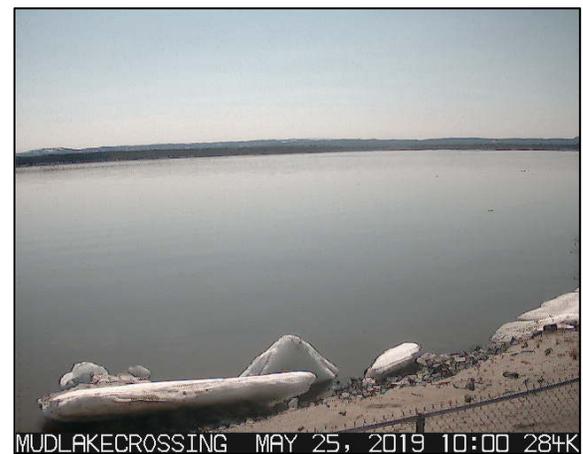
Figure 3.4 Mud Lake Web Camera Images During the Break-Up Process, May 16-25, 2019.

The break-up sequence for the period from May 4 to 25, 2019, is shown in Figures 3.3 and 3.4. The images from May 4 through 10 document the period pre-break-up where the river was still frozen over completely. Some melting along the margin of the river was starting to appear over this period, however the amount of melting along the shoreline only increased marginally over nine days. On May 18 there were still considerable amounts of unconsolidated ice in the river and this cleared rapidly over the next two days. The date of first crossing by boat was May 19, 2019 (Jordan Hope, pers. comm.). The duration of the break-up was about five days, which is comparable with observations from previous years and as reported by SNC-Lavalin (2012a) for 2012 (six days), 2014 (seven days, SEM 2014), 2015 (five to seven days, SEM 2015), 2016 (seven days, SEM 2016), 2017 (seven to nine days, SEM 2017) and 2018 (five days, SEM 2018).

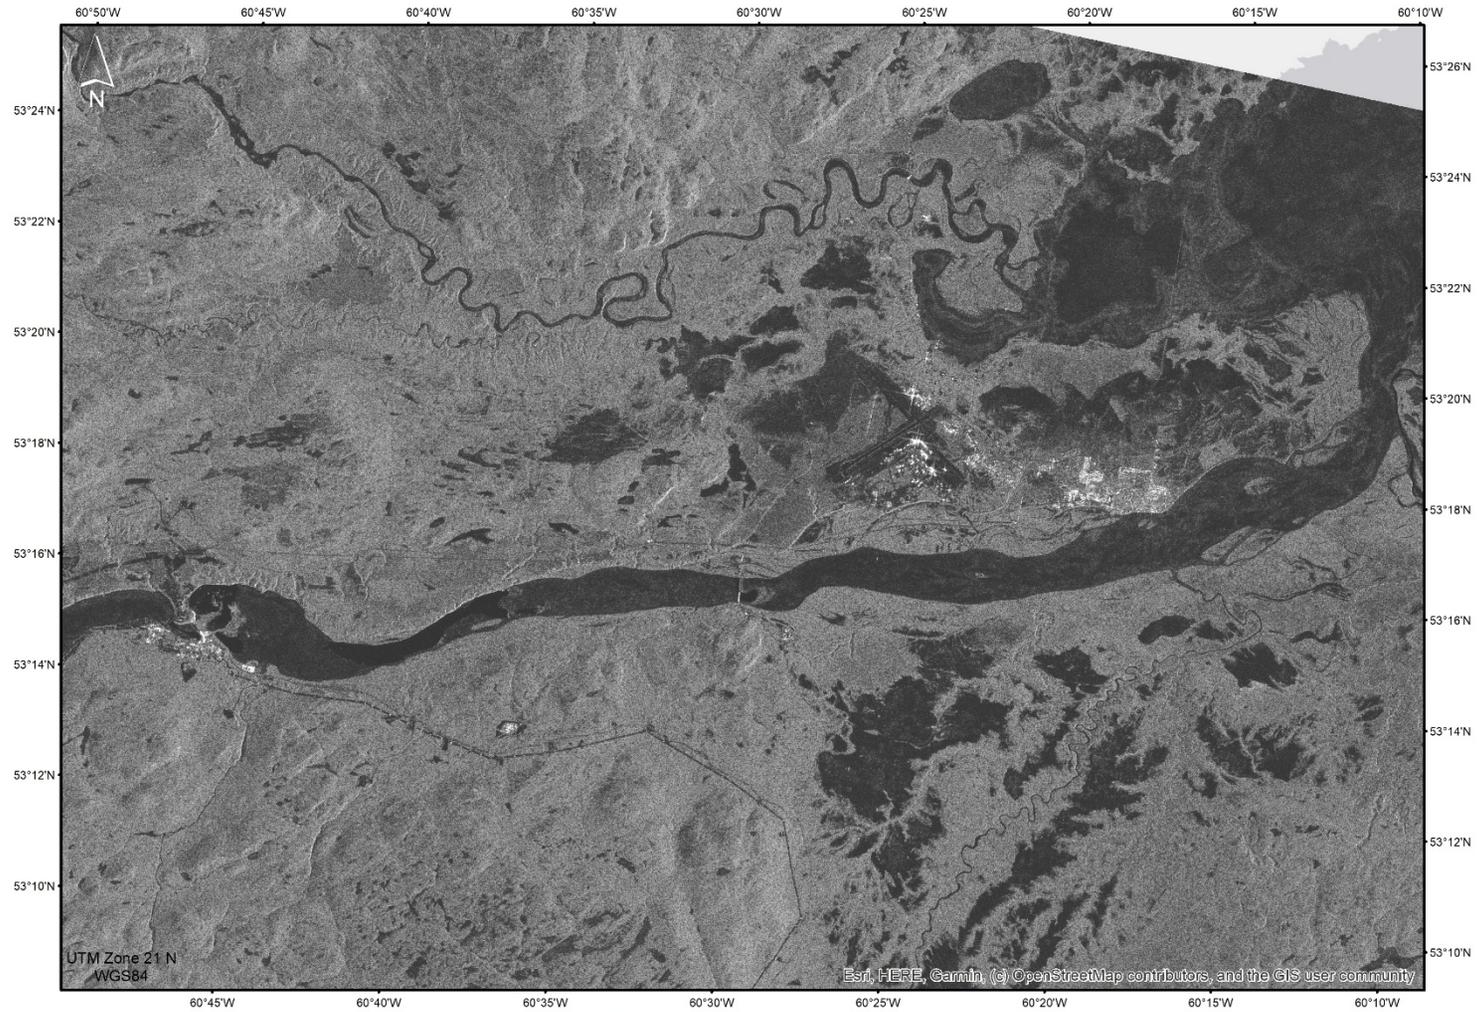
COSMO-SkyMed
May 6, 2019 21:45:34 UTC
May 5, 2019 21:51:34 UTC

Churchill River - Ice Cover
